BUTTE CREEK – SUTTER BYPASS WEIR 1

Feasibility Study and Alternatives Analysis

Prepared for
U.S. Fish and Wildlife Service

April 2024

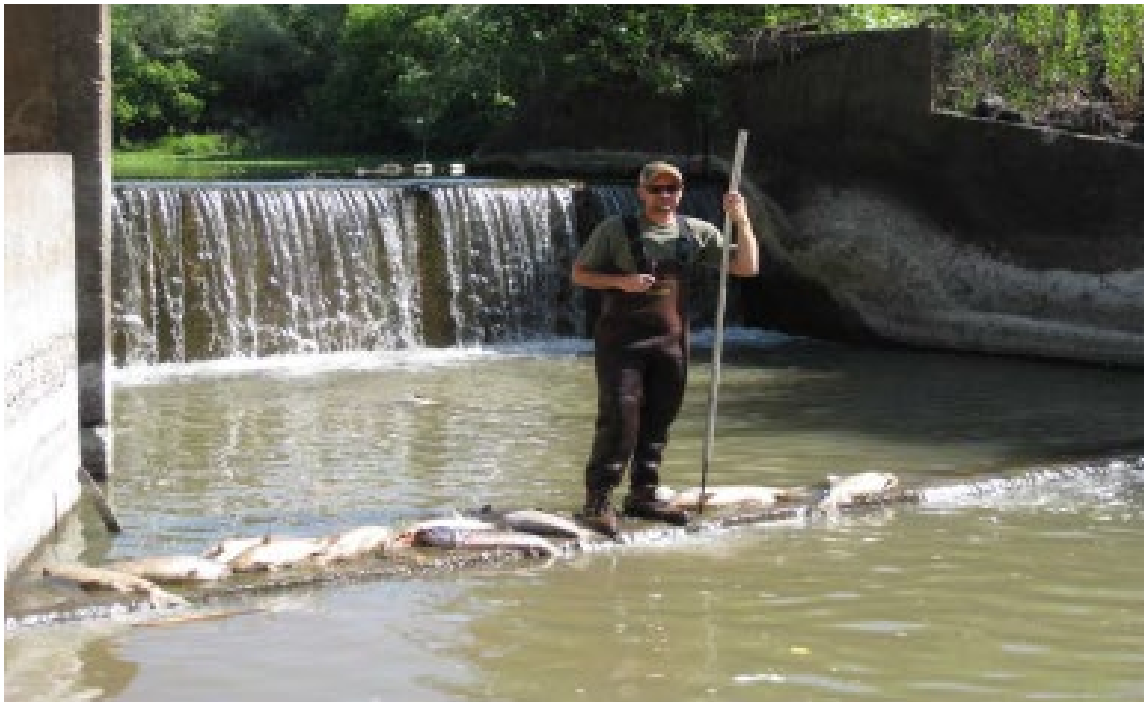
Figure 2
Fish Kill Downstream of Weir 1 (May 14, 2012)

Spring-run Chinook salmon are especially vulnerable to delay and mortality at these passage obstacles because they migrate during spring months (primarily March through June) when water diversion from the lower Butte Creek system is most significant (California Trout 2016). At these times, fish ladders at weir structures can cease functioning, resulting in delayed migration and even dramatic fish kills. In the West Borrow Channel, Weir 1 is the first obstacle in the watershed faced by returning salmon and despite significant investments to improve fish passage in the past decades (see Section 1.2.1, below) Weir 1 is the last structure in the Sutter Bypass requiring retrofitting to facilitate the passage of spring-run Chinook salmon. Fish kills at the weir have been well-documented in recent years (CDFW, 2012; CDFW, 2013a, 2013b)¹ (**Figure 2**).

¹ On May 14th, 2012, a total of 32 carcasses were collected and disposed of in an adjacent riparian corridor. On April 24th, 2013, approximately 30-35 carcasses were found. On May 4th, 2013, approximately 15 carcasses were found.

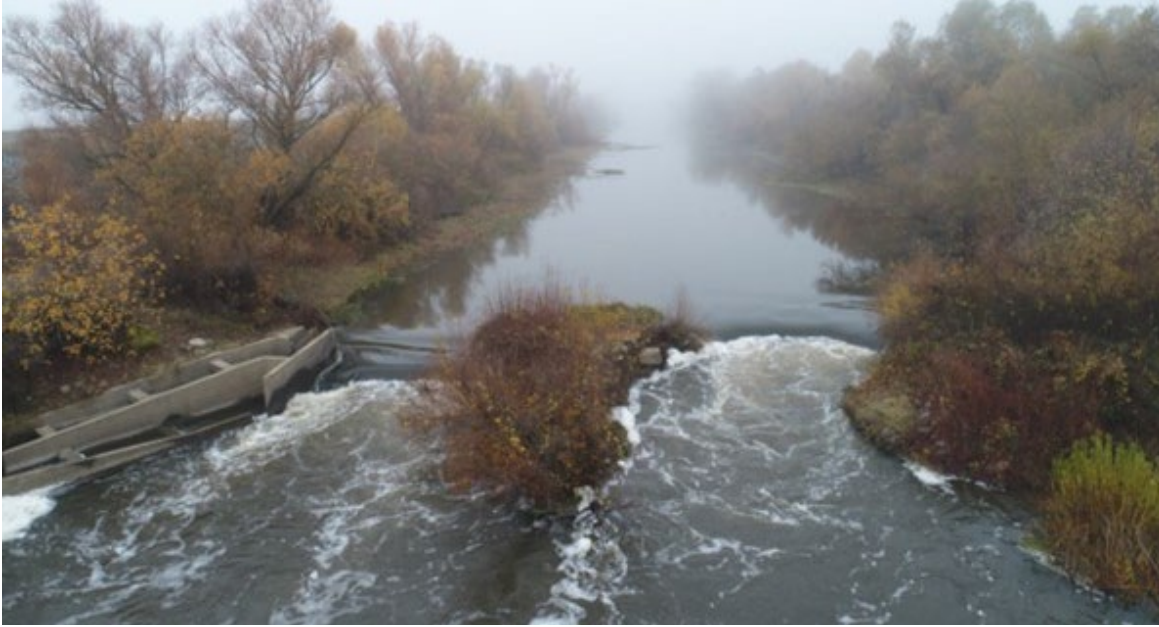
Figure 5

Weir 1 comprises a concrete wall without stop logs, a fish ladder, a berm, and a flowing headcut watercourse (Figures 4 and 5). Removing the stoplogs resulted in water spilling over the wide opening in a shallow, dispersed manner (see the waterfall in the background of Figure 2). The breached east abutment, which created the flowing headcut watercourse, does not pass adult spring-run Chinook salmon during low flows. Together, the breach and the wide notch in the weir have worsened fish passage by dispersing flow, diminishing the attraction flow to the fish ladder, which was left in place during the modifications that took place in 2005.

Note: Flow in WBC during the time of this image is estimated to be ~300 cfs based on preliminary hydraulic modeling conducted as part of this project. At lower flows in Butte Slough (around 350 cfs), the division between the East and West Borrow Canal is approximately 30 and 70 percent, respectively, based on a 2/7/20 discharge measurement by CDFW.

Drone Image of Weir 1 Facing Upstream (North) (January 2020)

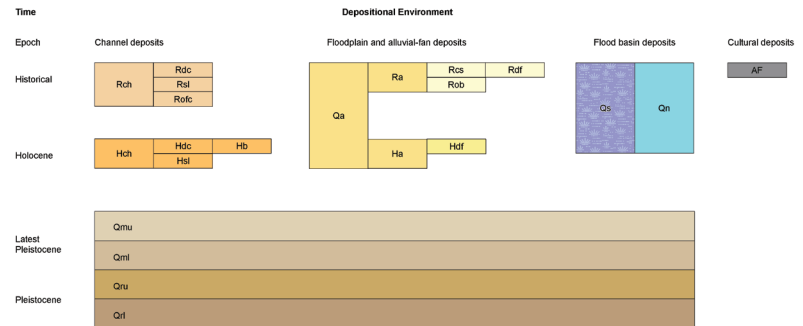
Figure 6
Surficial Geology Map of Weir 1 Area

The surficial geologic conditions within the study area are driven by Feather River and Sutter Basin morphology (**Figure 6**). A westward movement characterizes the localized groundwater interactions around Weir 1 because the Sutter Bypass is not a “natural channel” and is not located at the bottom of the Sutter Basin, which is located west of Weir 1. While groundwater flows towards the west, surface water can be pumped from the agricultural fields west of the weir into the WBC. As mentioned above, the western levee of the Sutter Bypass was intentionally breached as part of the 1997 Meridian flood fight.

More recent Holocene-aged and historical channel deposits (map units Hch and Rch) are incised into the basin deposits. These southwest-trending alluvial channel deposits locally underlie the bypass levee and result in local differences in material textures beneath the levee. The mapped channels are about 250 feet wide. In this area, the channels are estimated to be about 6 to 8 feet deep and are typically filled with sand, silt, and clay in a fining-upward sequence, i.e., coarser-grained and overlain by about 1 to 2 feet of silt and clay. This sedimentary sequence may be conducive to seepage where relatively more permeable channel sands are overlain by a relatively thin, fine-grained blanket layer (Source URS 2014).

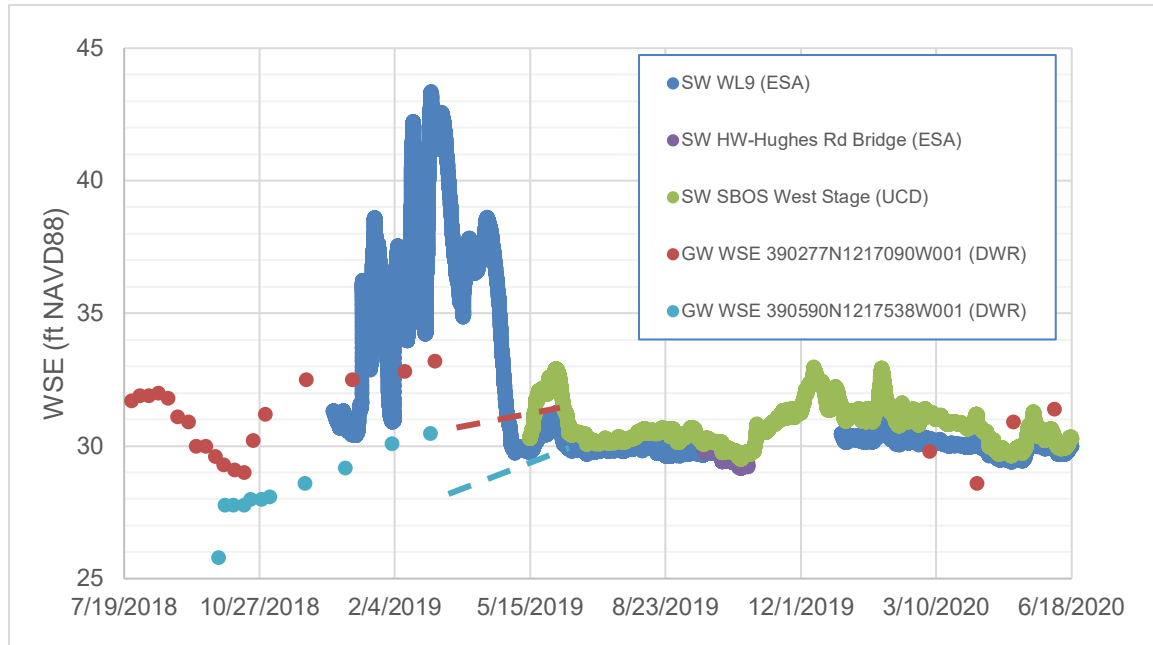
Figure 8

There is limited overlap between the various monitoring data. Still, a comparison of data between July 2018 and June 2020 (two years of record) suggests that groundwater levels may exceed surface water levels as the Sutter Bypass drains and flows recede within the WBC (see the dashed extrapolation lines in **Figure 8**). Under these conditions, the WBC would become a gaining reach.

Surface Water and Groundwater Levels Near Weir 1. Dashed lines show potential ground water levels as the flows in the bypass recede.
