Butte Creek - Sutter Bypass Weir 1  
Feasibility Study and Alternatives Analysis

## 5. MODEL RESULTS

Appendix B  
**Preliminary Geotechnical  
Assessment**

## **Engineering Drawings**

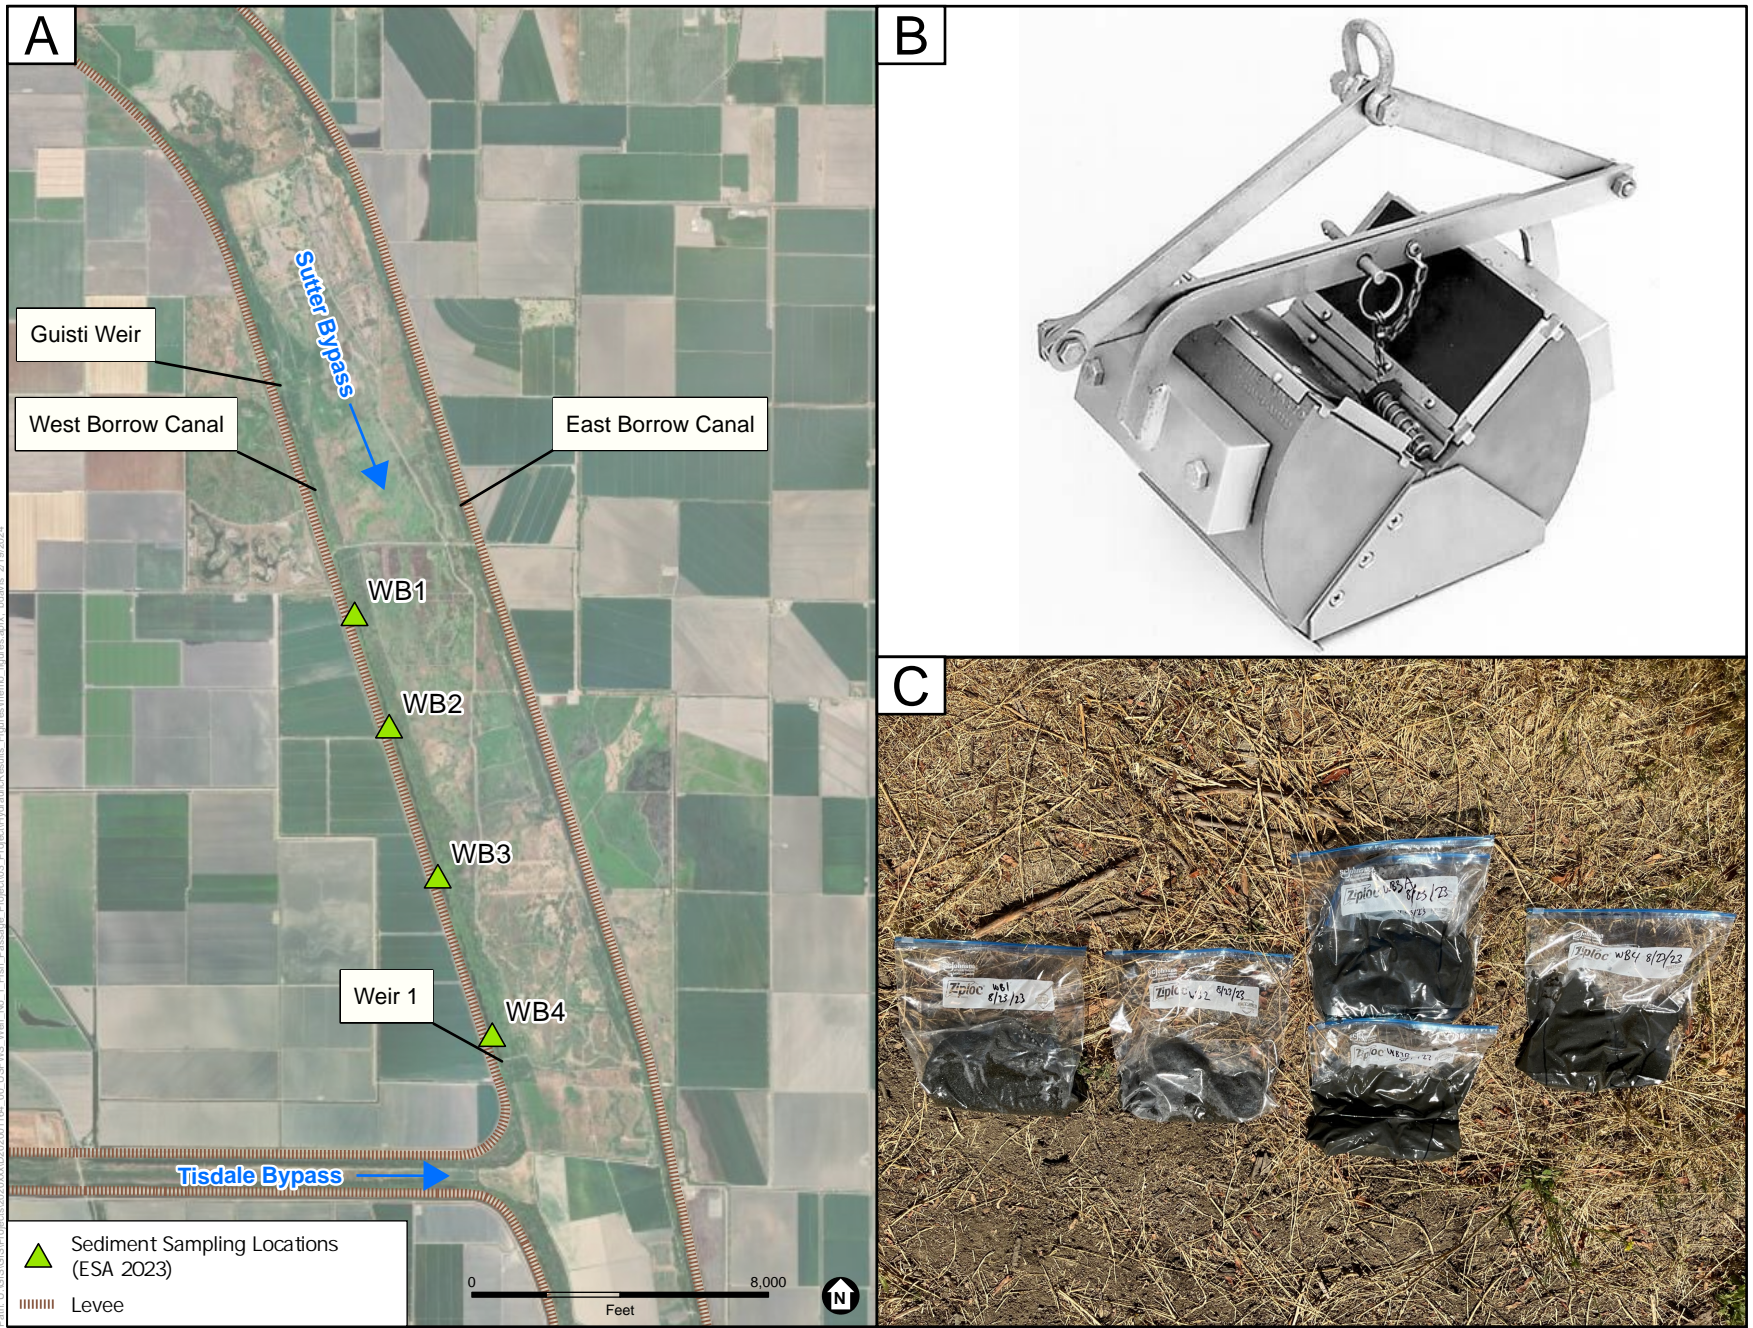
**Figure A-11**  
(A) Sediment Sample Locations, (B) Petite Ponar Sediment Sampler, and (C) Sediment Samples

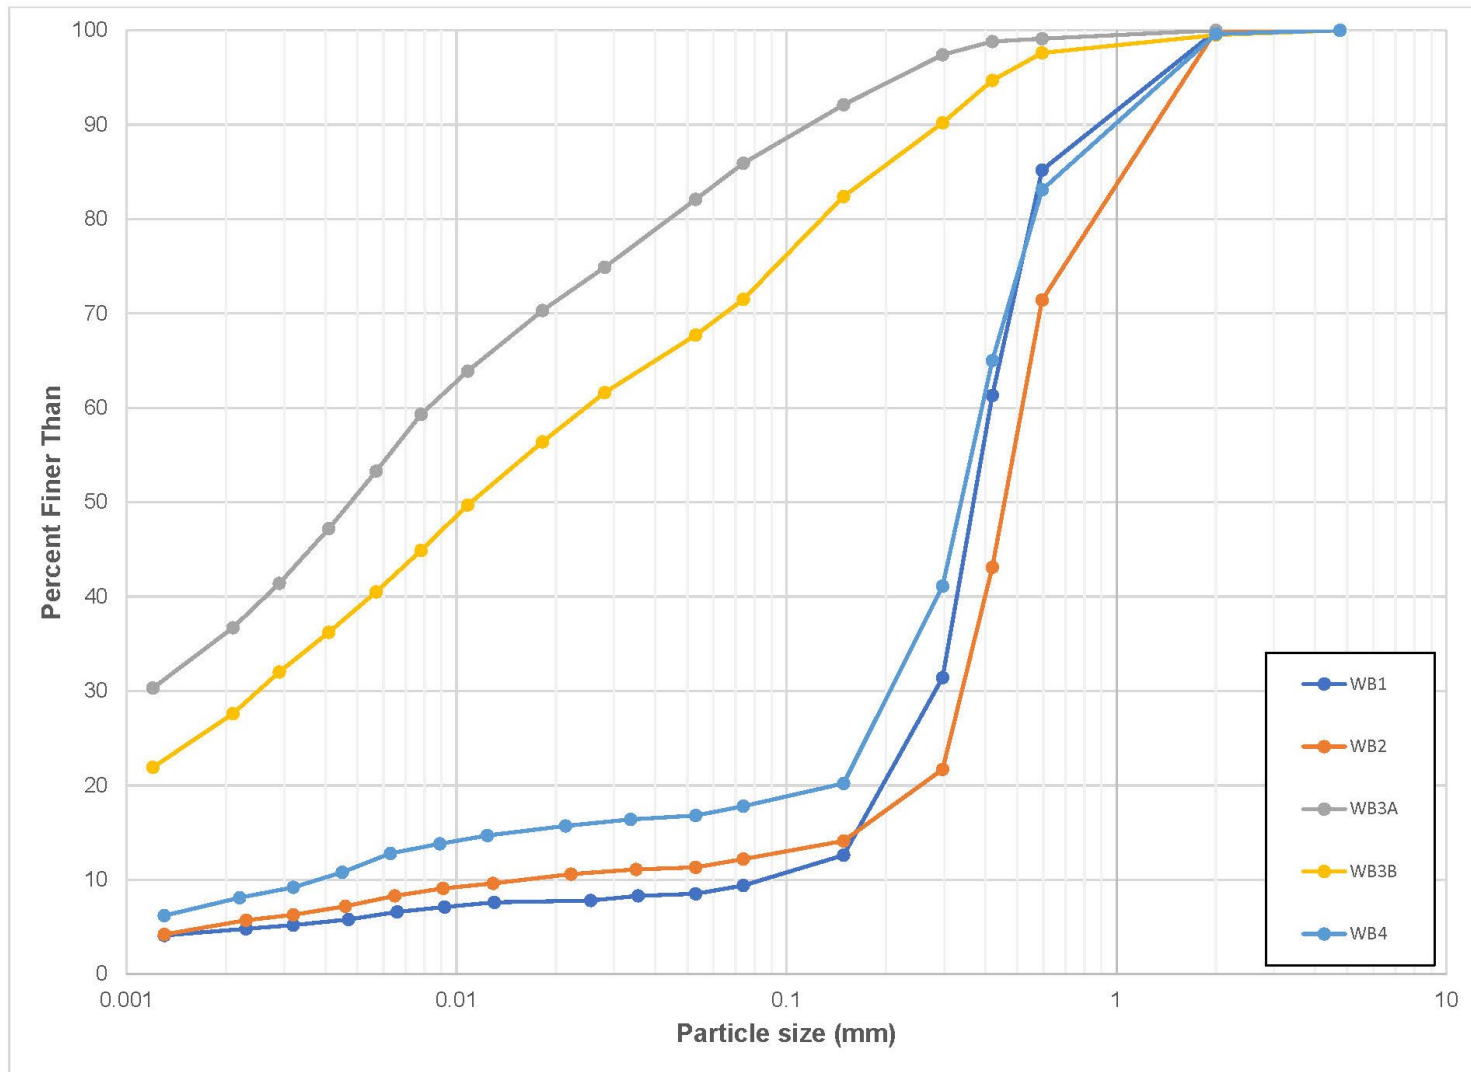
**Figure A-12**  
Sediment Gradations for WBC Sampling Locations

A discharge of 1000 cfs was used since the associated water surface profile in the WBC resulted in the initial inundation of most wetlands between the canal and refuge. This discharge represents our preliminary estimate of bankfull or effective discharge under the Alternative A scenario. Because most of the sediments sampled in the WBC could be characterized as “silty sand”, the average of Group 1 sediment gradations were used to define the incoming sediment load, where  $d_{84} = 0.68\text{mm}$ ,  $d_{50} = 0.39\text{mm}$ , and  $d_{16} = 0.13\text{mm}$ .

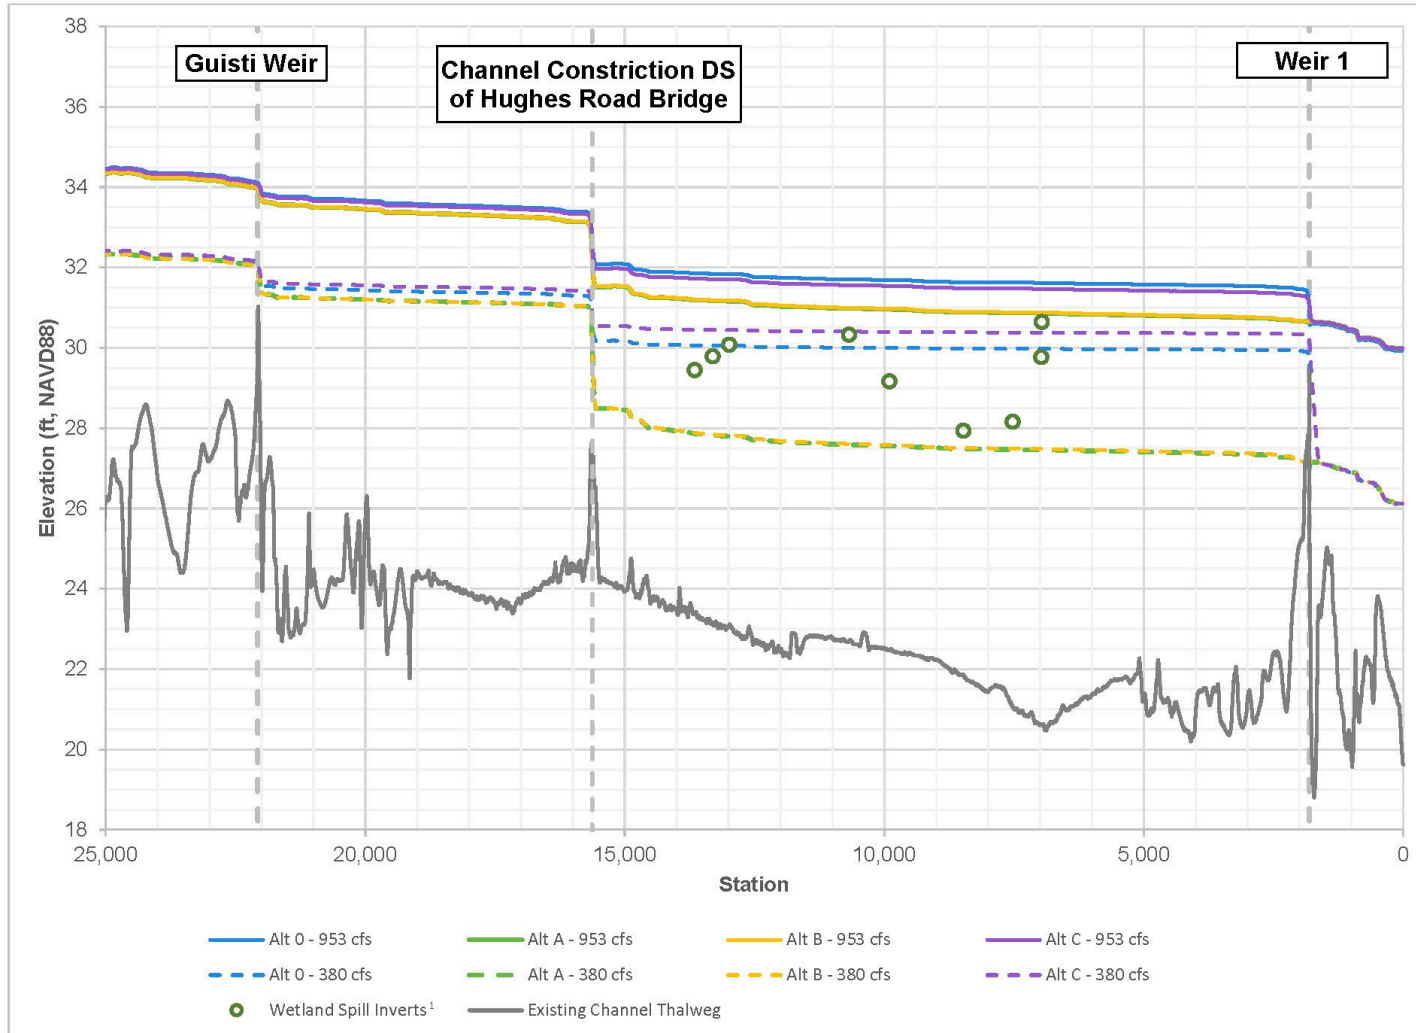
Notes: <sup>1</sup> Wetland spill inverts are from an ESA survey conducted in 2023. The 2D HEC-RAS existing conditions terrain is generally 0.5 to 2 feet higher at the surveyed locations due to interpolation with CVFED LIDAR data (DWR 2010).

**Figure A-16**  
Two Dimensional HEC-RAS Model Longitudinal Profiles for the Median and High Passage Flow

Using the 2D HEC-RAS model, under existing conditions a discharge of 650 to 750 is required to inundate the various wetlands. Due to broader wetland activation, a discharge of 750 cfs was used to represent the bankfull flow under existing conditions. More discharge (~1000 cfs) is required to activate the wetlands for Alternatives A and B due to removal of the weir, an inline hydraulic control within the WBC. Although Alternative C maintains the existing sill elevation of Weir 1, additional roughness elements (boulders and large cobble on the ramp) downstream of the weir raises the upstream water surfaces profile. Approximately 550 cfs is required to inundate the wetlands under Alternative C. Although not explicitly modeled, it is expected that Alternative D would result in a similar or slightly higher upstream water surface profile as Alternative C. The water surface profile under Alternative D may be higher due to the slight constriction from the fish ladder and embankment structures.

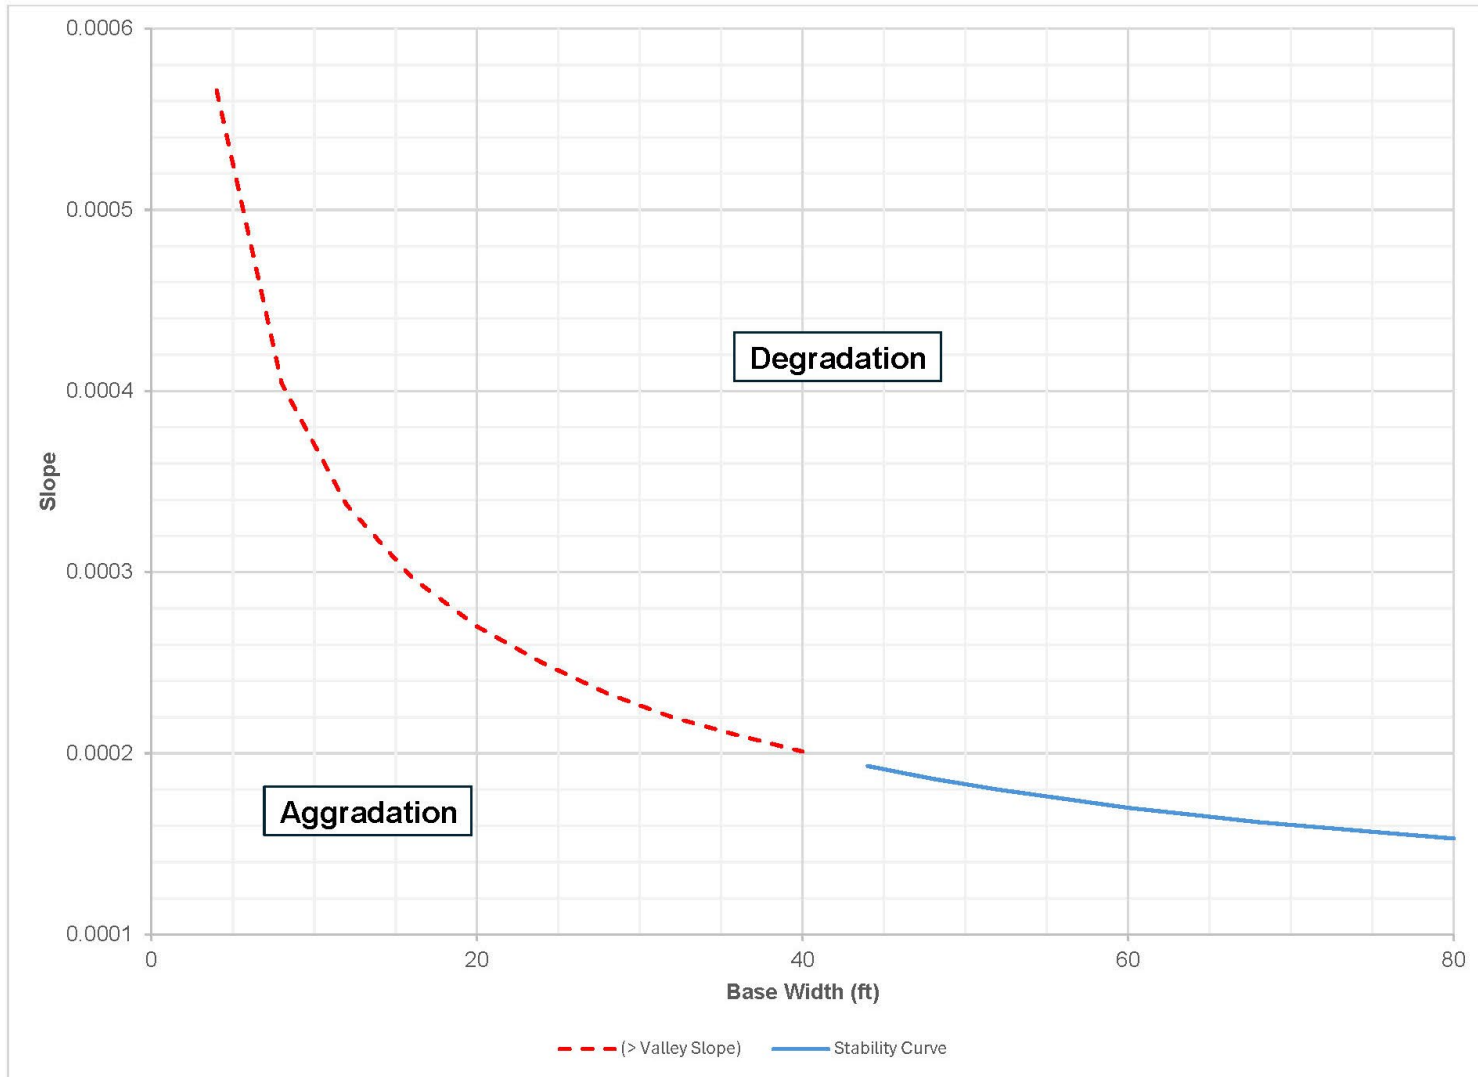
**Figure A-17**  
Stability Curve for Width and Slope

Results of the stability analysis indicate that Alternative A, as currently designed, would not result in aggradation or degradation of the channel. If the channel bottom is gradually transitioned from upstream to downstream, a bed slope equivalent to the average valley and channel slope of 0.0002 feet/feet is achievable. Maintaining the valley slope and average bottom width of 40 feet results in a stable channel design (**Figure A-17**). This configuration of slope and depth supports channel depths in the ballpark of those observed under existing conditions (**Figure A-18**). As anticipated, the stability charts indicate that a bed slope steeper than the valley slope may result in degradation (incision) of the channel bed. It is unlikely that the bed slope would flatten below 0.0002 feet/feet if the average channel geometry is maintained throughout the upstream to downstream transition of the channel bed as currently designed.

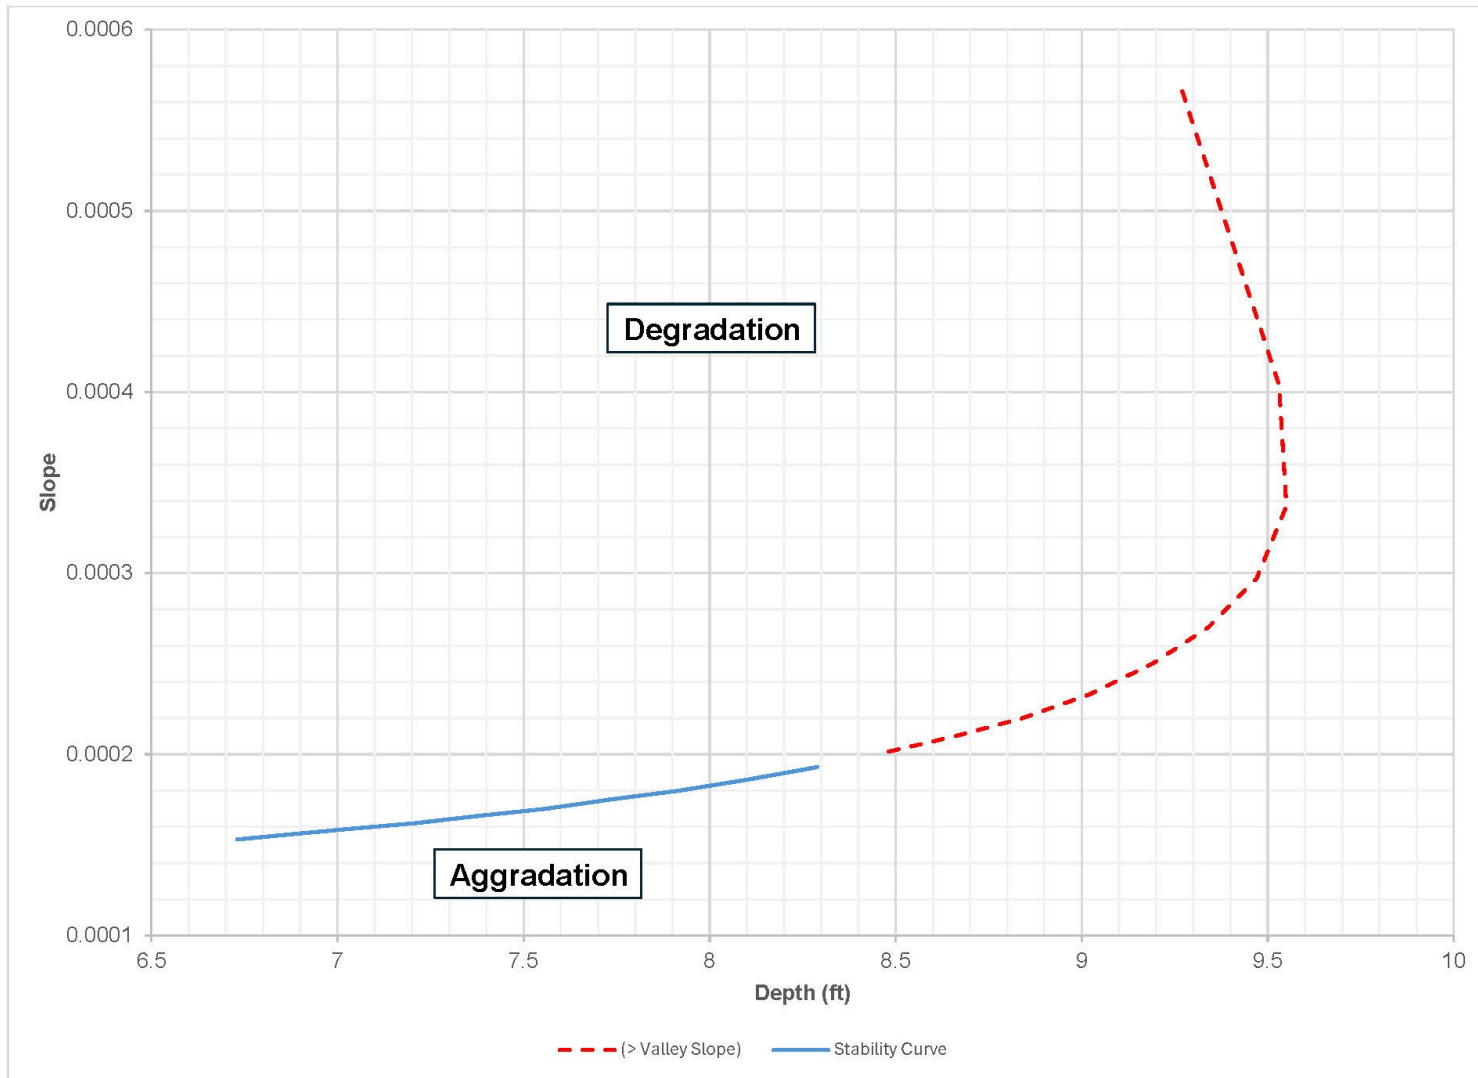
**Figure A-18**  
Stability Curve for Depth and Slope

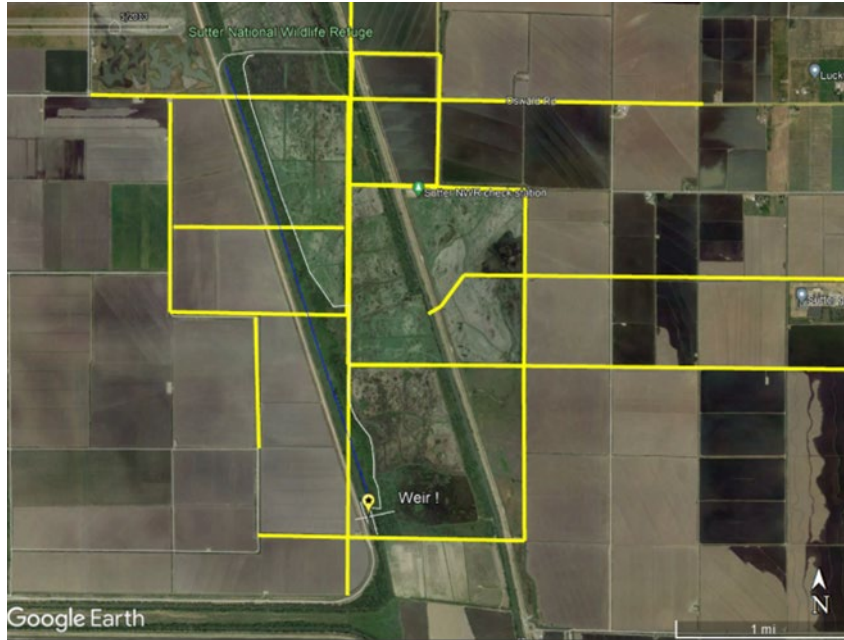
**Figure 1 – Current and former agricultural field boundaries**

The available aerial photographs and review of historical topographic maps indicate that the levee west borrow area is approximately 150 feet wide and started (or stopped) at the location of Weir 1, leaving a narrow width (estimated to have once been 50 to 60 feet wide) of native material, likely maintained as farm access from the east to west side of the bypass. The borrow excavation then continued south of this crossing. The borrow cuts were likely made by drag line excavation methods. Aerial photographs from 2014/2015 show drought low water levels exposing shallow borrow excavation along the east side of the west borrow cut; therefore, the deeper excavation is limited to the western portion of the borrow cut.

DWR performed a detail mapping of the surface geology for each levee area assessed. The mapping is based on a review of aerial photography from 1937. A portion of this map is reproduced as Figure 2. The approximate weir location can be determined based on the agricultural field boundaries shown in in Figure 1.

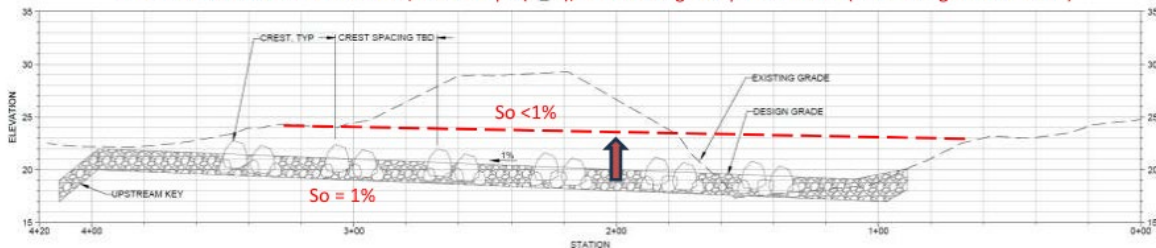
- 300-foot-long roughened channel with upstream key and downstream apron
- Engineered streambed material with riffle crests at a **1% bed slope** (more gradual than rock ramp)
- **Potential to raise bed elevation, lower slope (<1%), and hold higher upstream WSE (than configuration below)**

Figure 3 – Alternatives B and C (Source ESA, 2023)

### Alternative B: Roughened Channel

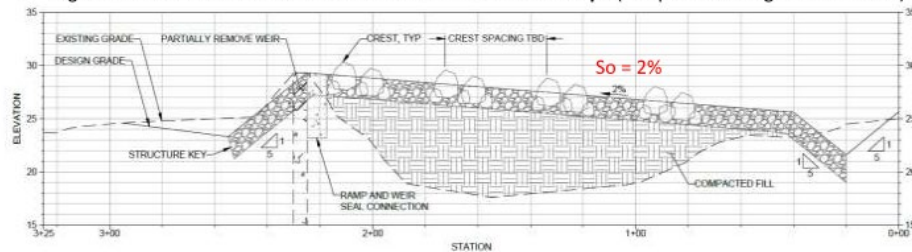
- 190-foot-long roughened ramp with upstream (behind weir) and downstream keys (at riffle)
- Requires considerable fill below ramp (volume TBD)
- Engineered streambed material with riffle crests at a **2% bed slope** (steeper than roughened channel)

### *Alternative C: Rock Ramp*

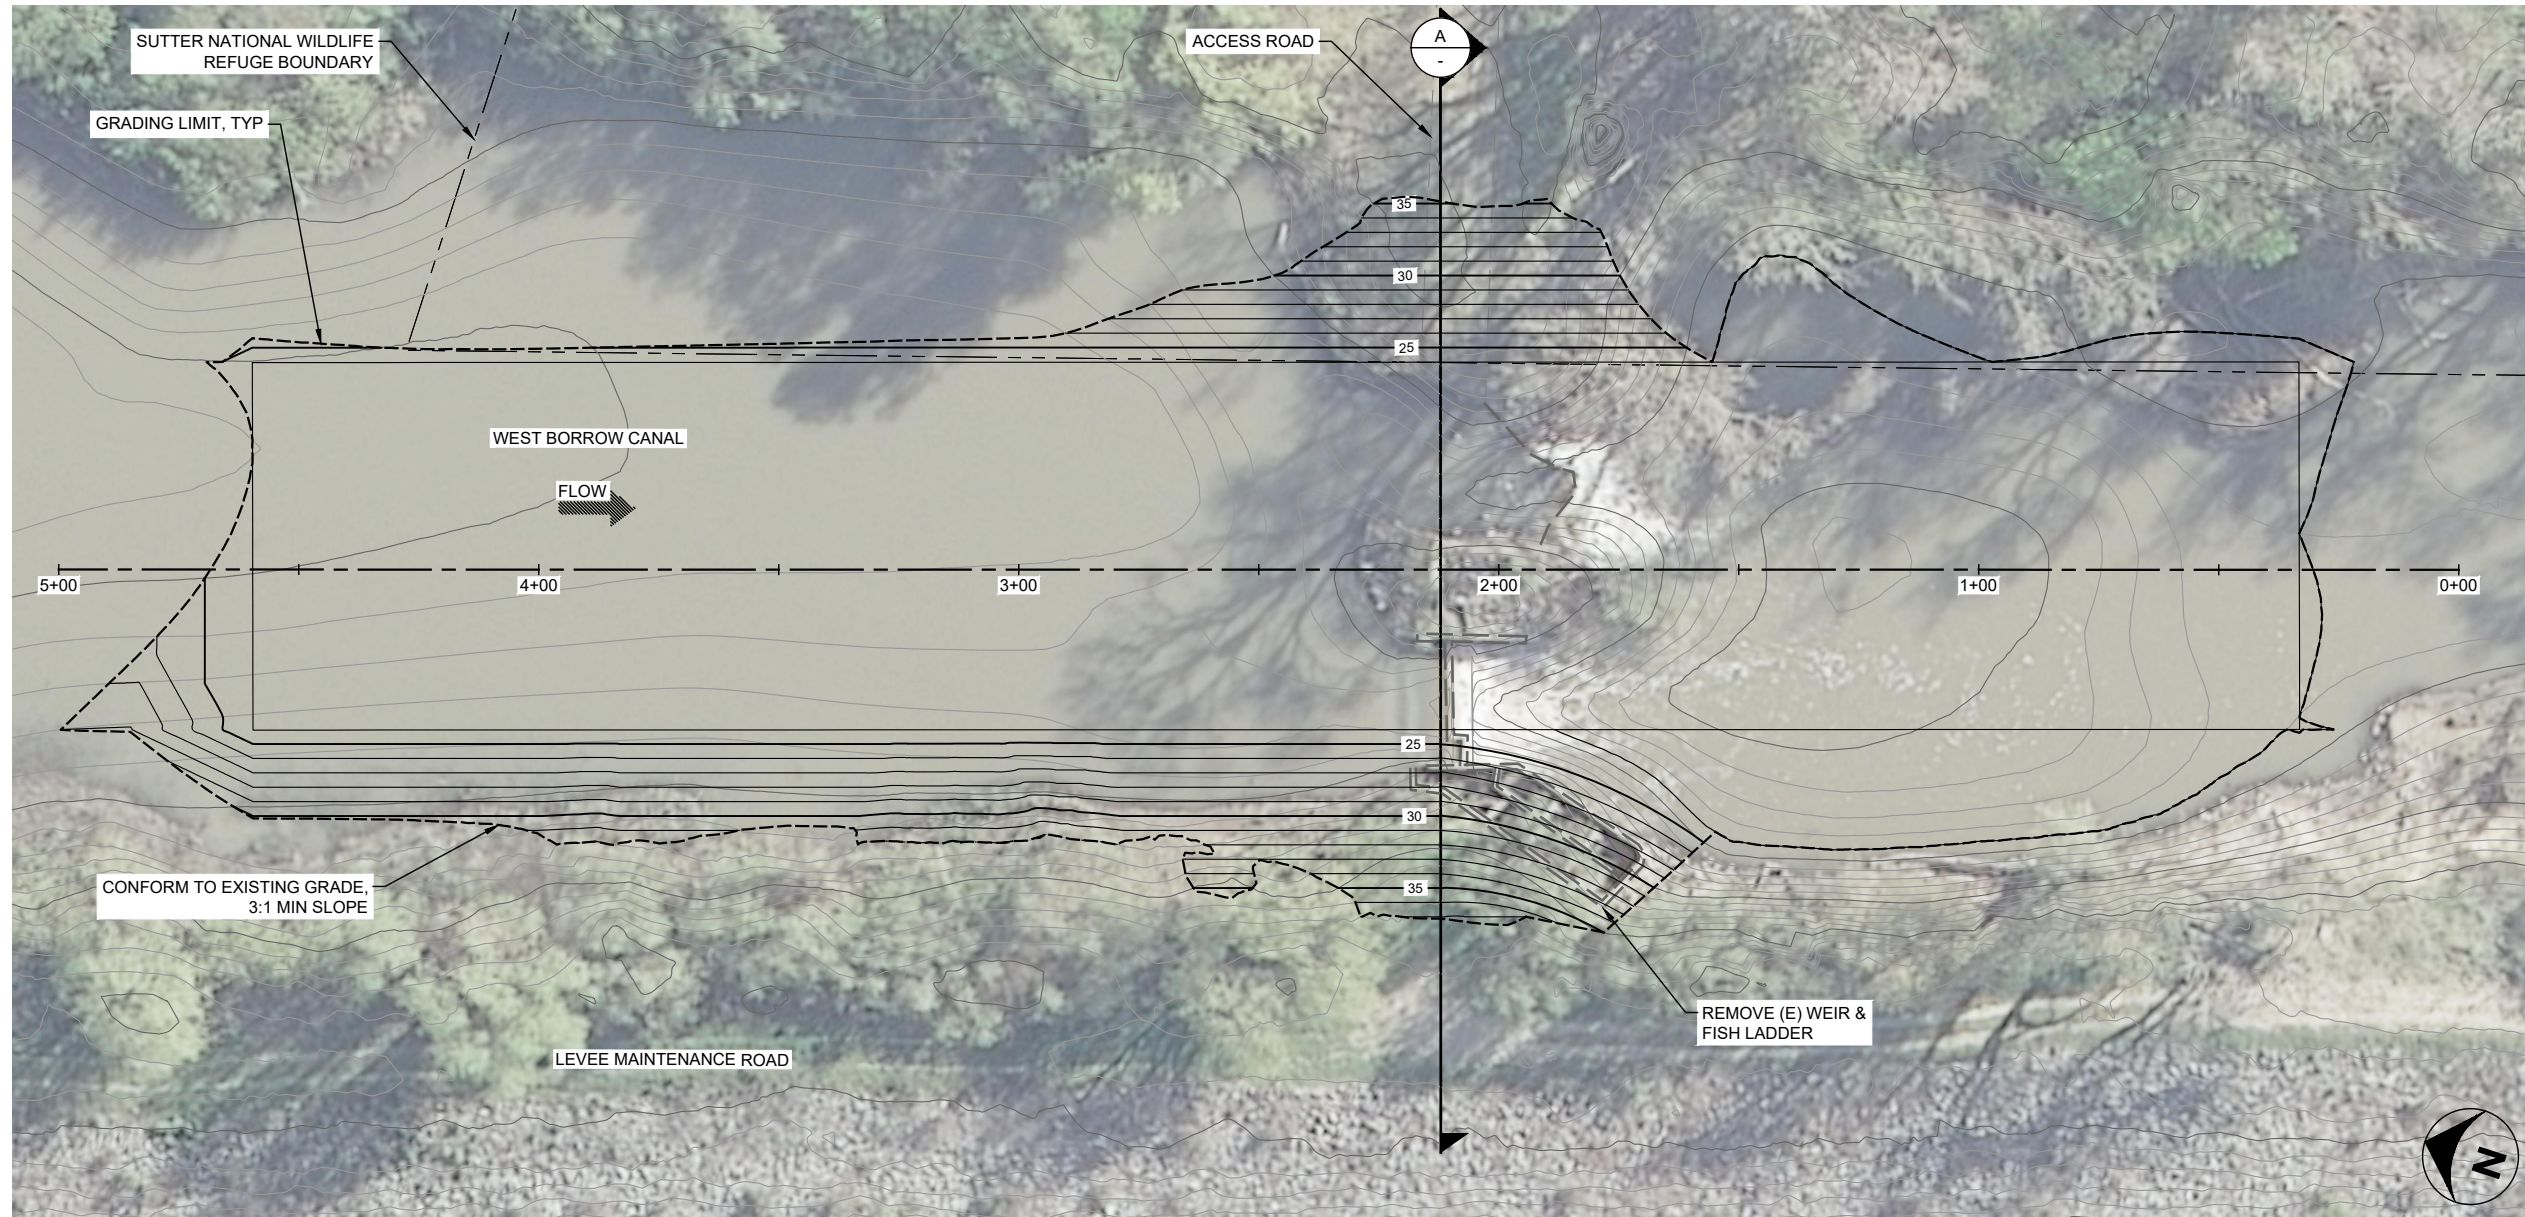
ALTERNATIVE A - WEIR REMOVAL  
PLAN 1" = 40'

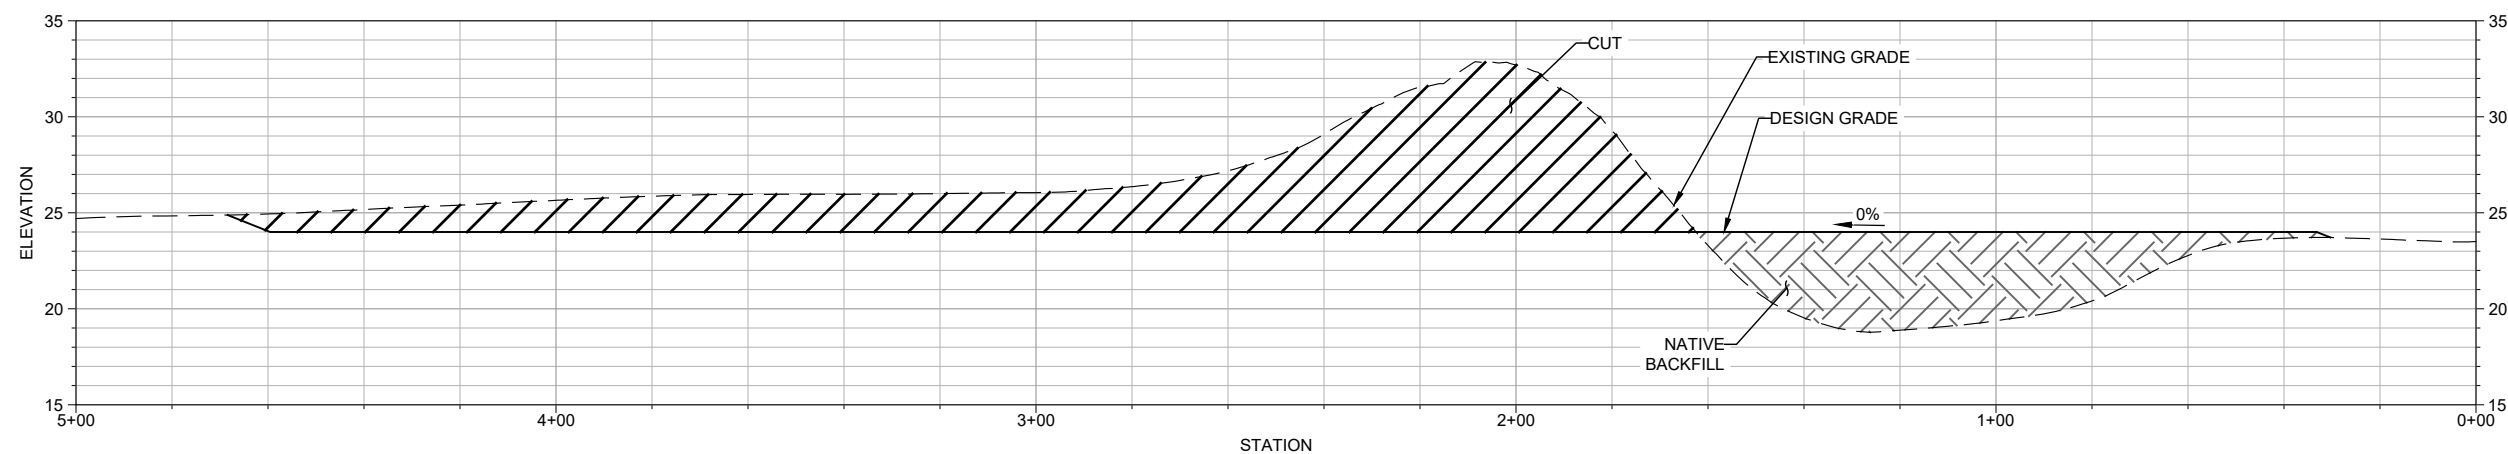
ALTERNATIVE A - WEIR REMOVAL  
PROFILE NOT TO SCALE

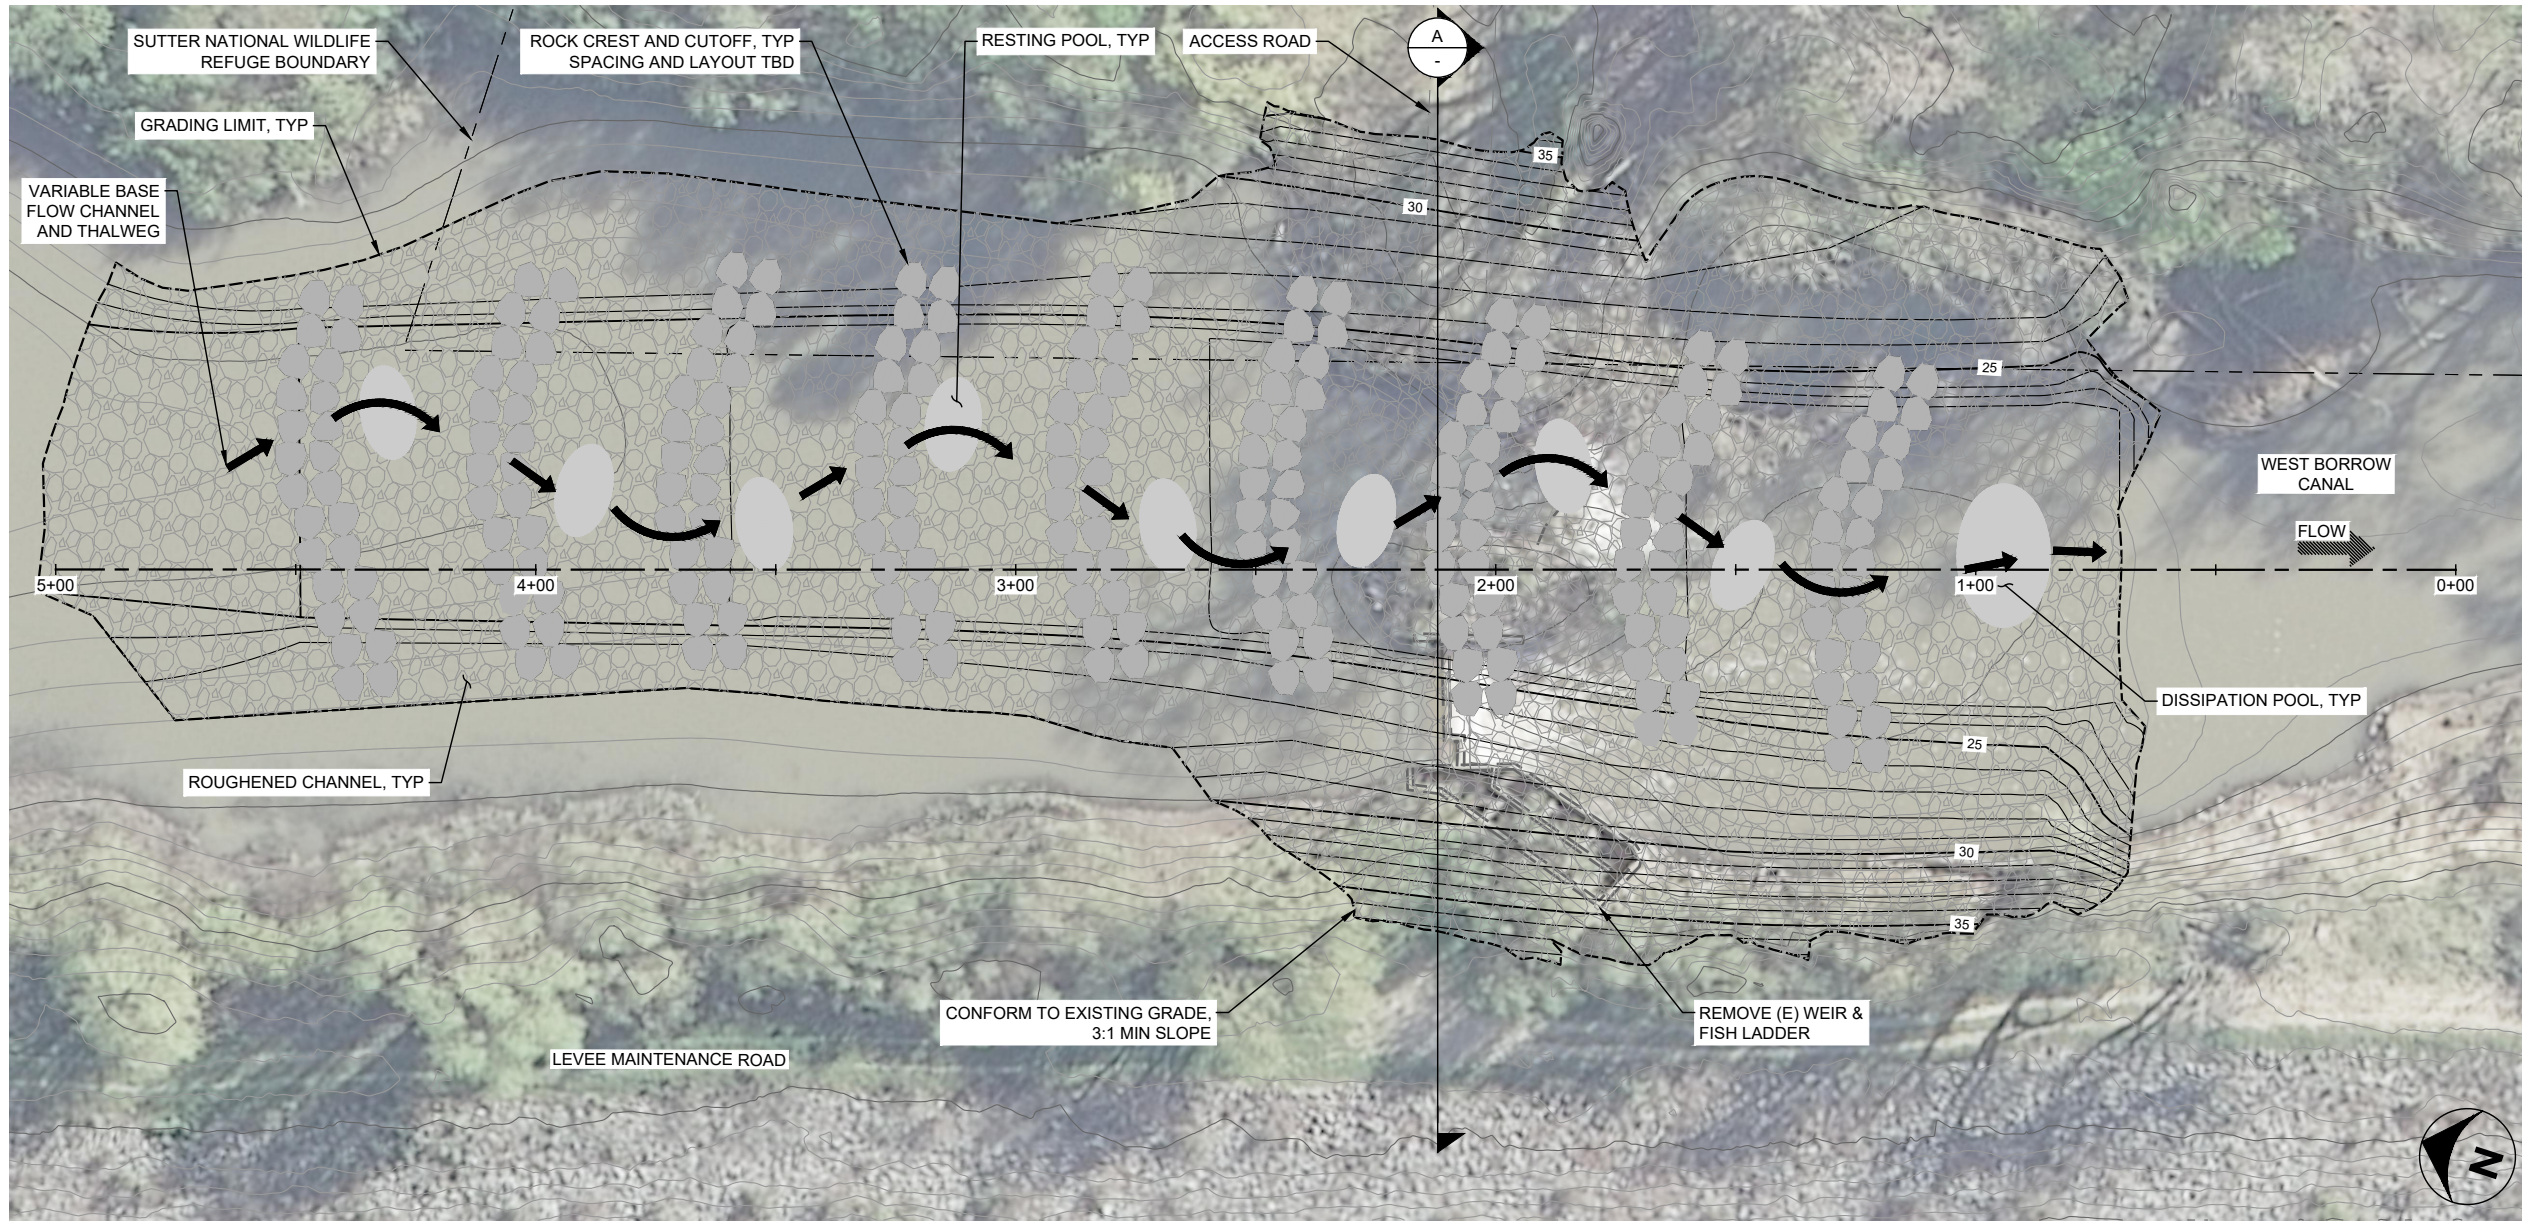
ALTERNATIVE B - ROUGHENED CHANNEL  
PLAN 1" = 40'

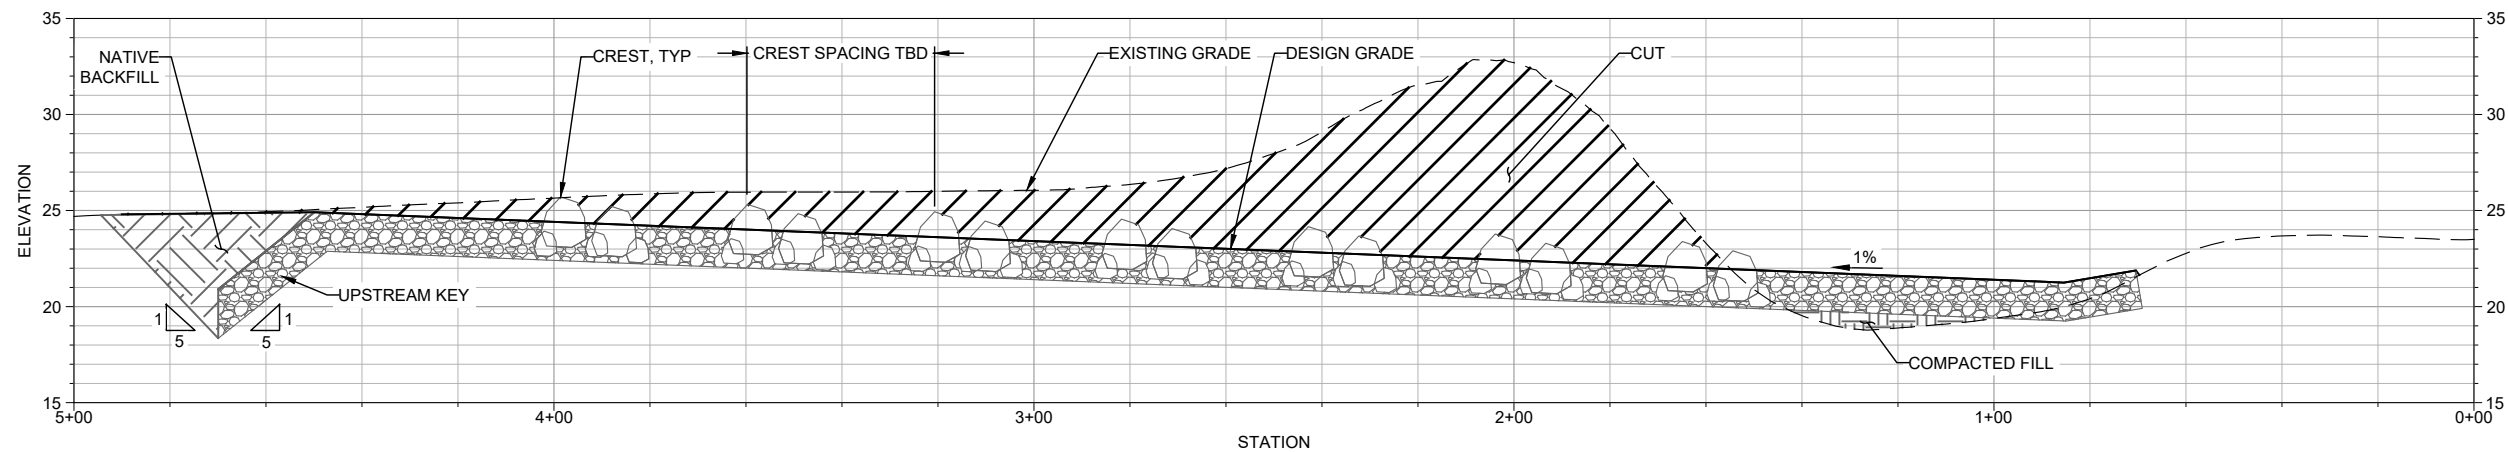
ALTERNATIVE B - ROUGHENED CHANNEL  
PROFILE NOT TO SCALE

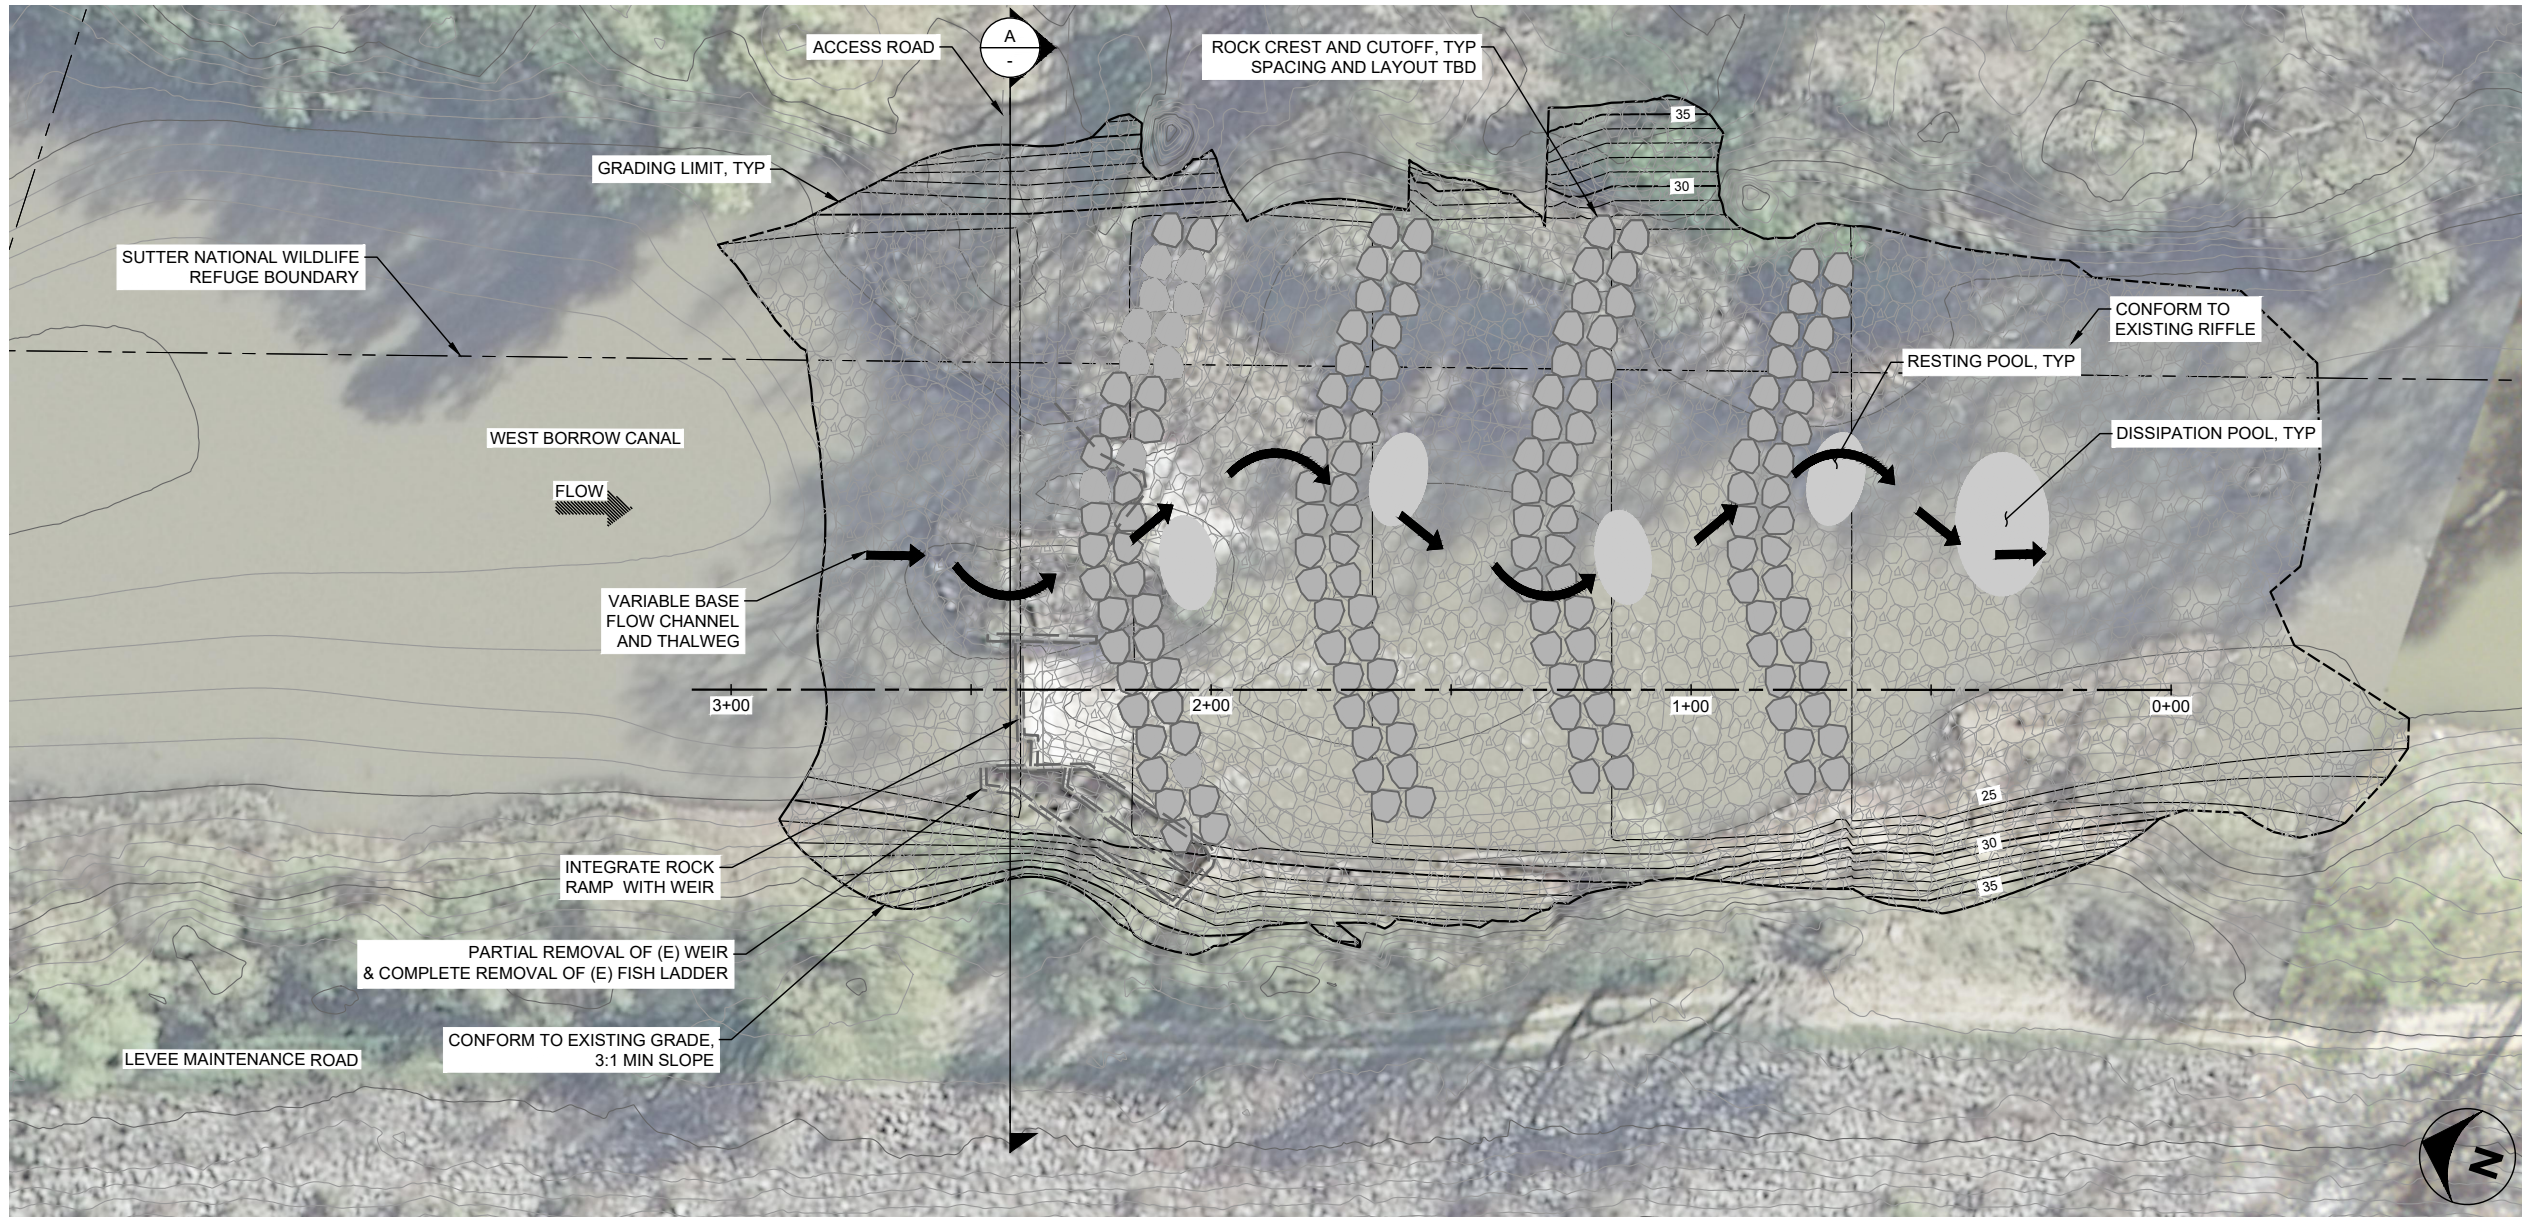
○ ALTERNATIVE C - PARTIAL WEIR REMOVAL WITH ROCK RAMP  
PLAN 1" = 40'
