Butte Creek - Sutter Bypass Weir 1  
Feasibility Study and Alternatives Analysis

## 5. MODEL RESULTS

Appendix B  
**Preliminary Geotechnical  
Assessment**

## **Engineering Drawings**

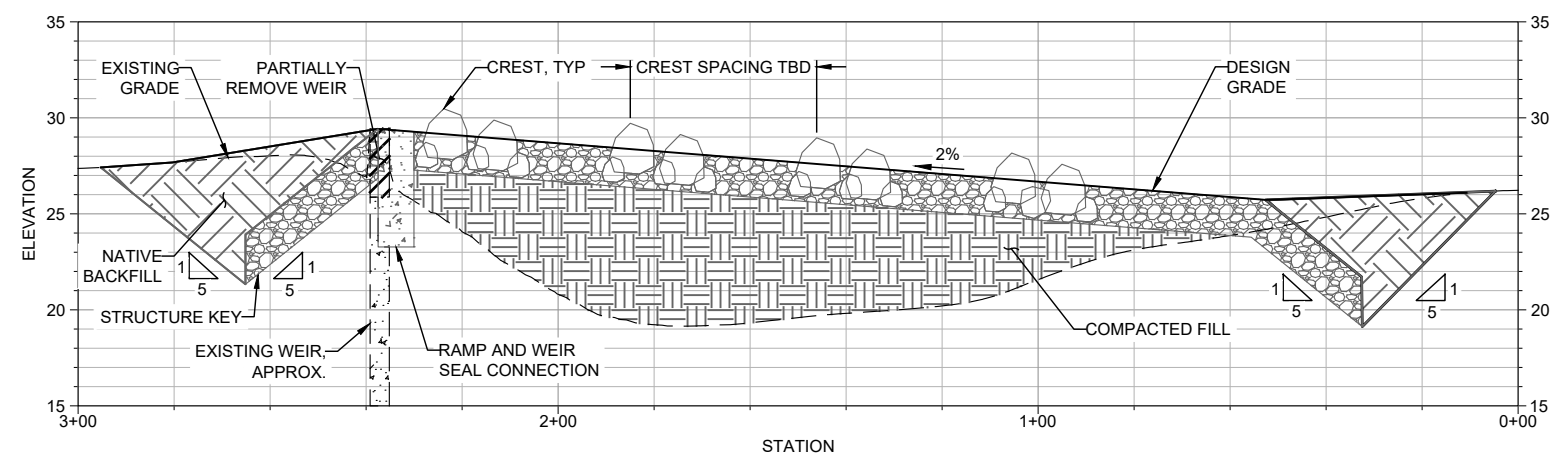
○ ALTERNATIVE C - PARTIAL WEIR REMOVAL WITH ROCK RAMP  
PROFILE NOT TO SCALE

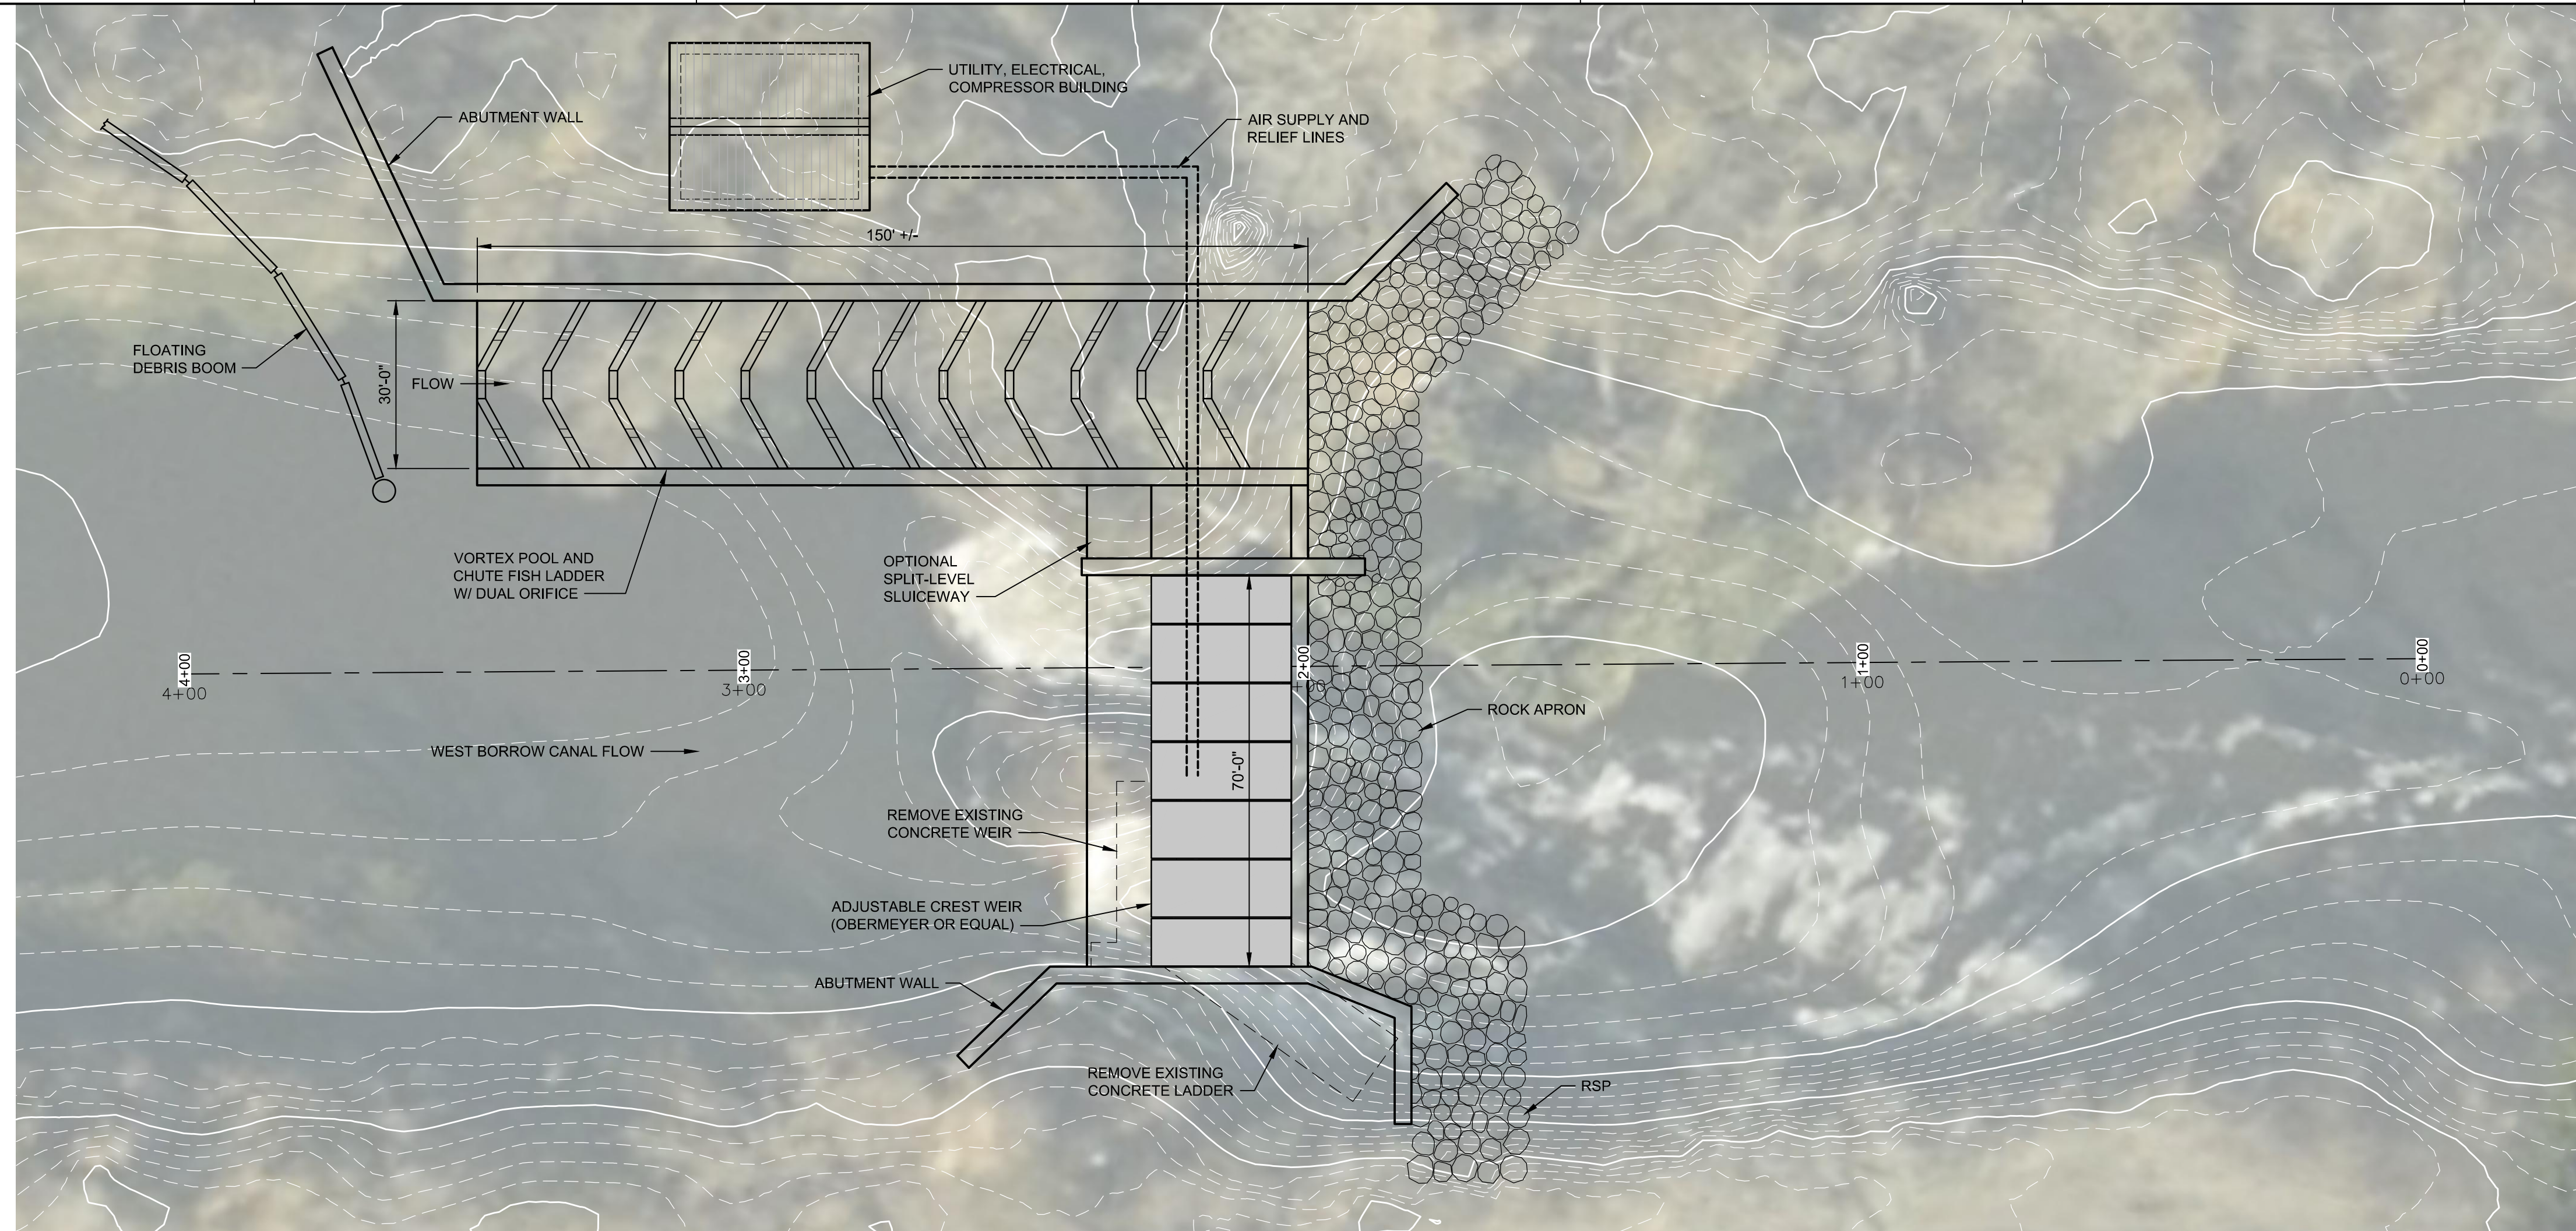
**PLAN**  
SCALE: 1" = 20'

**ALTERNATIVE D  
PLAN AND PROFILE**

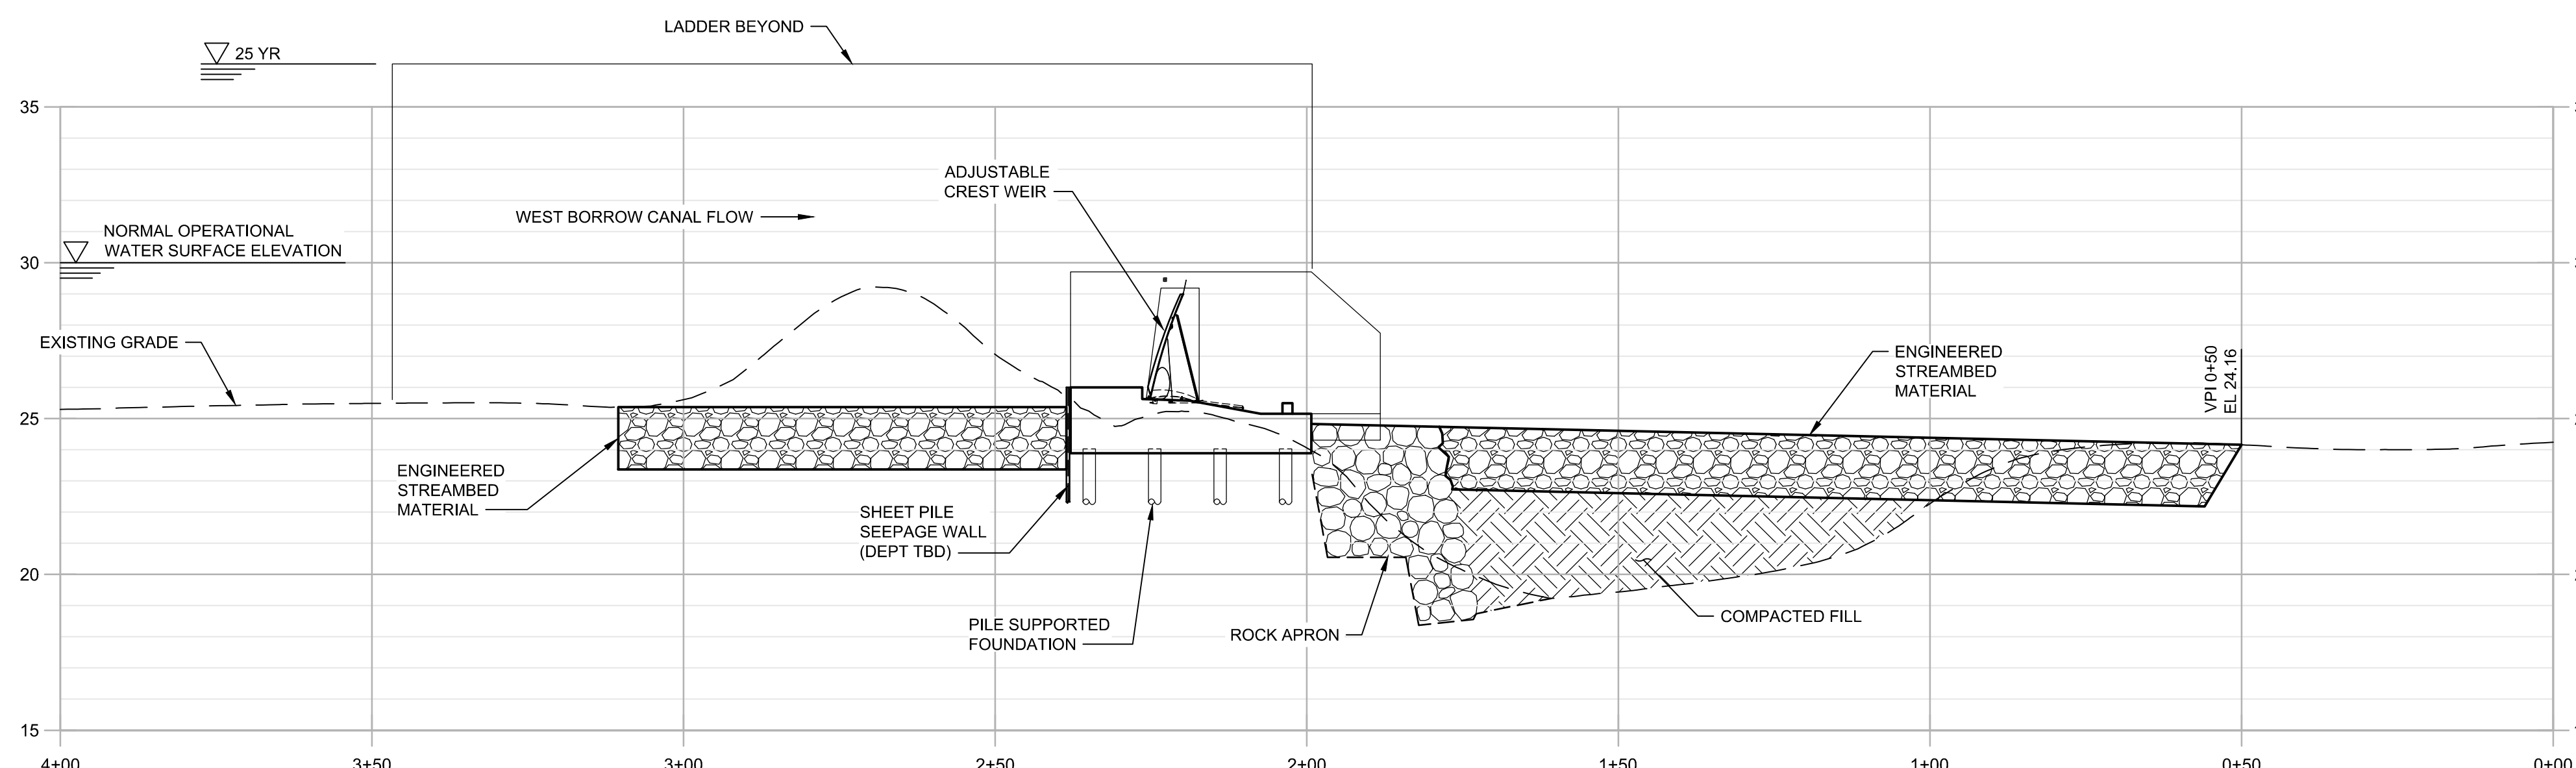
**PROFILE**  
HORIZONTAL SCALE: 1" = 20' VERTICAL SCALE: 1" = 4'

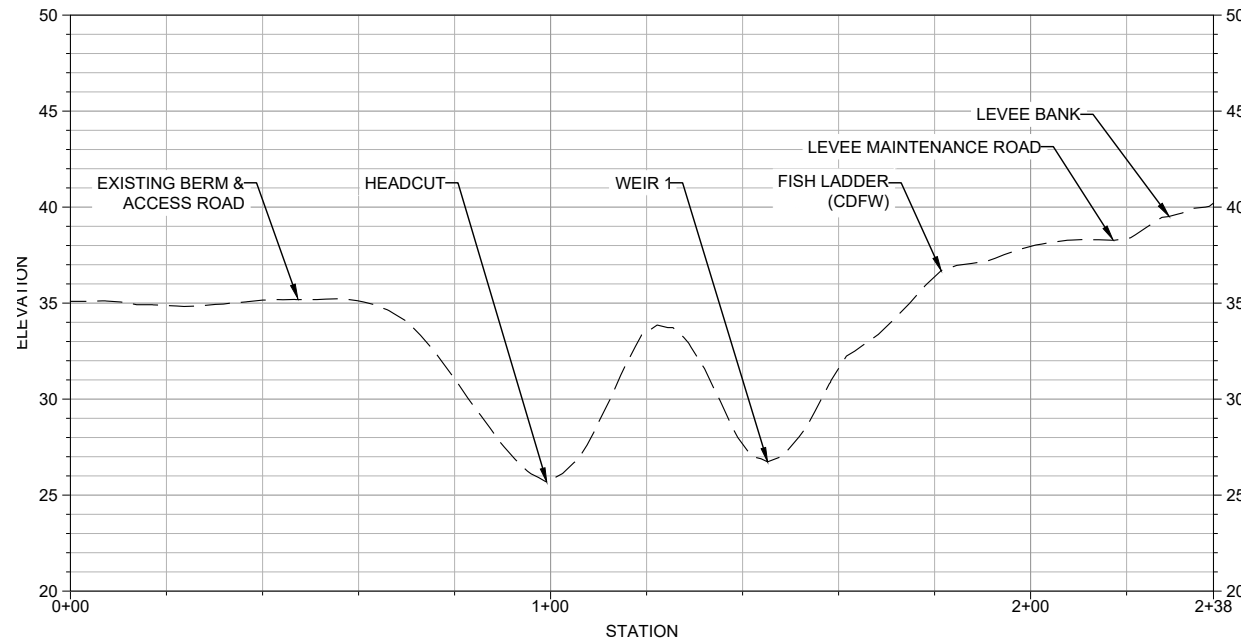
**A**  
SECTION  
**ALTERNATIVE 0 - NO ACTION**  
NOT TO SCALE

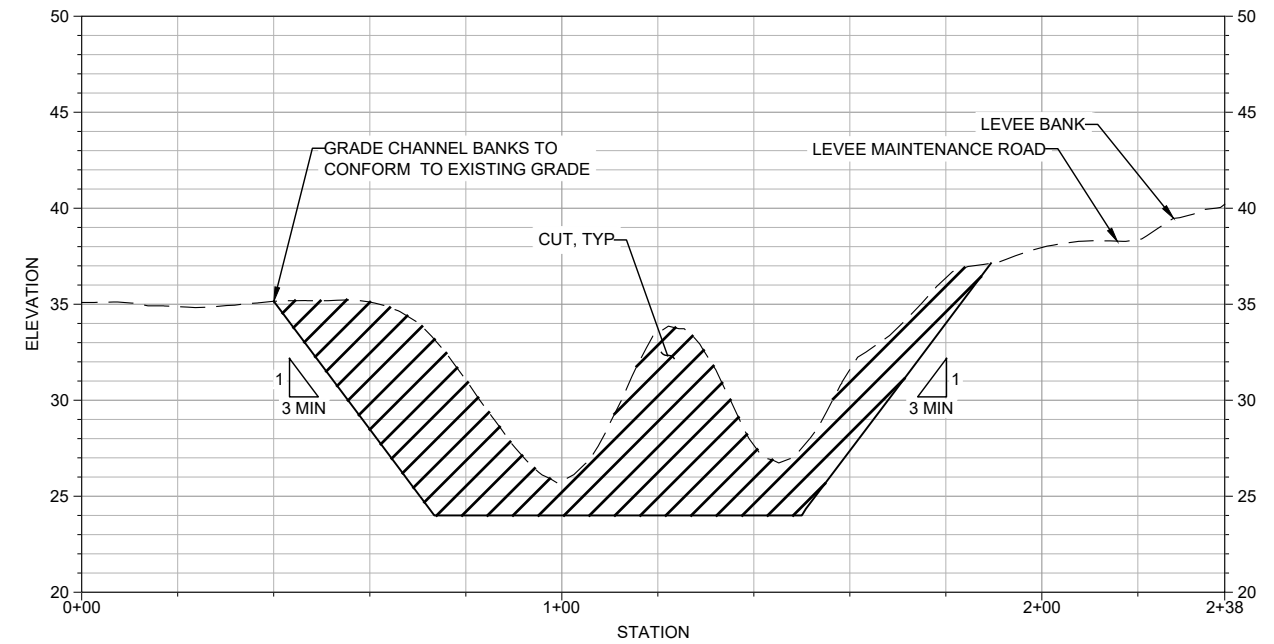
**A**  
SECTION  
**ALTERNATIVE A - WEIR REMOVAL**  
NOT TO SCALE

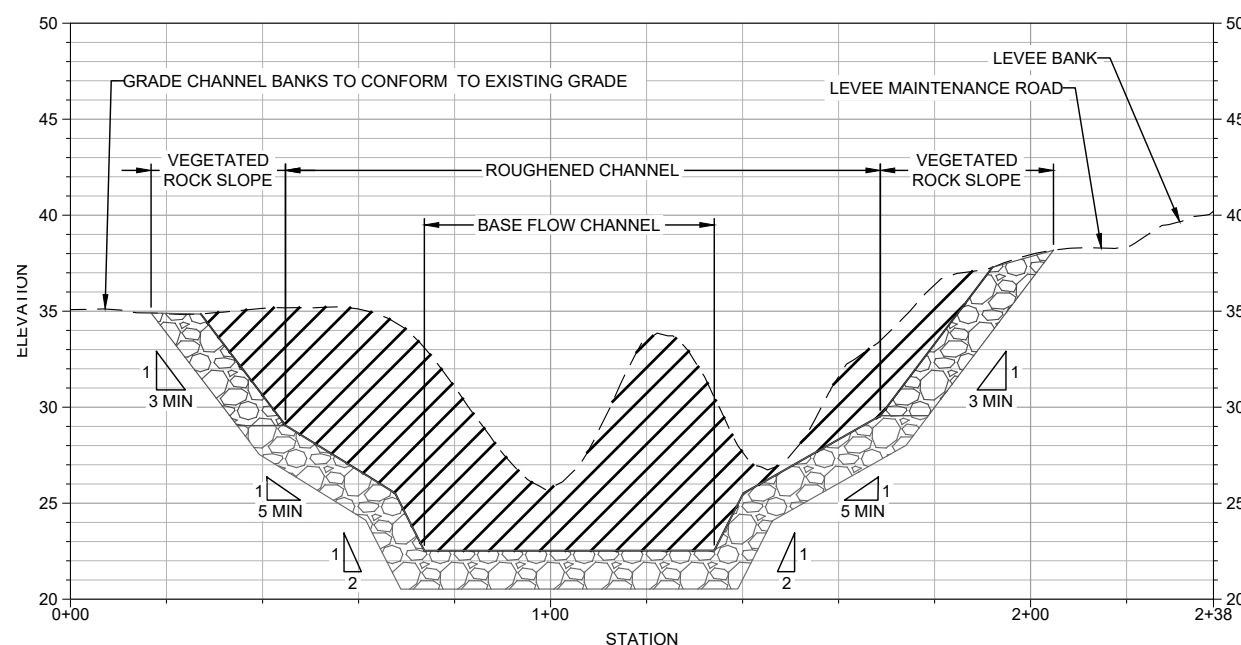
**A**  
SECTION  
**ALTERNATIVE B - ROUGHENED CHANNEL**  
NOT TO SCALE

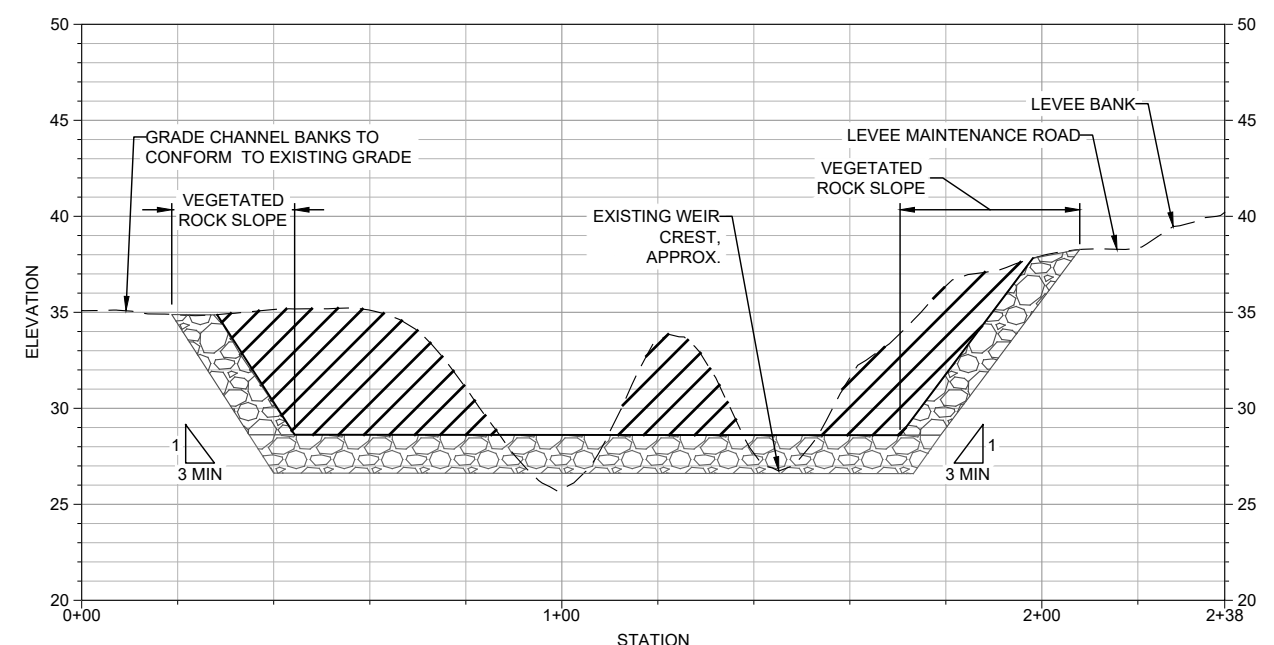
**A**  
SECTION  
**ALTERNATIVE C - PARTIAL WEIR REMOVAL WITH RAMP**  
NOT TO SCALE
